**Historic Resources Survey  
City of McMinnville  
Yamhill County, Oregon**

<b>Site Address</b>		<b>Owner at Time of Survey</b>			
407 NE 13th Street		Gary & Lavada Palmer			
<b>Map/Tax Lot</b>	<b>Current Zoning</b>	<b>Special Tax Assessment</b>	<b>Downtown Historic District</b>		
R4416CC02400	R-2	No	No		
<b>Subdivision Name</b>		<b>Block</b>	<b>Lot</b>	<b>Lot Size</b>	<b>Quadrant</b>
Beaumont Park		7	5	6,000 sq.ft.	NE
<b>Site Number</b>	<b>Aerial Number</b>	<b>Resource Classification</b>	<b>Resource Number</b>	<b>Historic Significance</b>	
4.2	J-9	B	256	Secondary Resource #27.1

**Historic Resource No. B256**

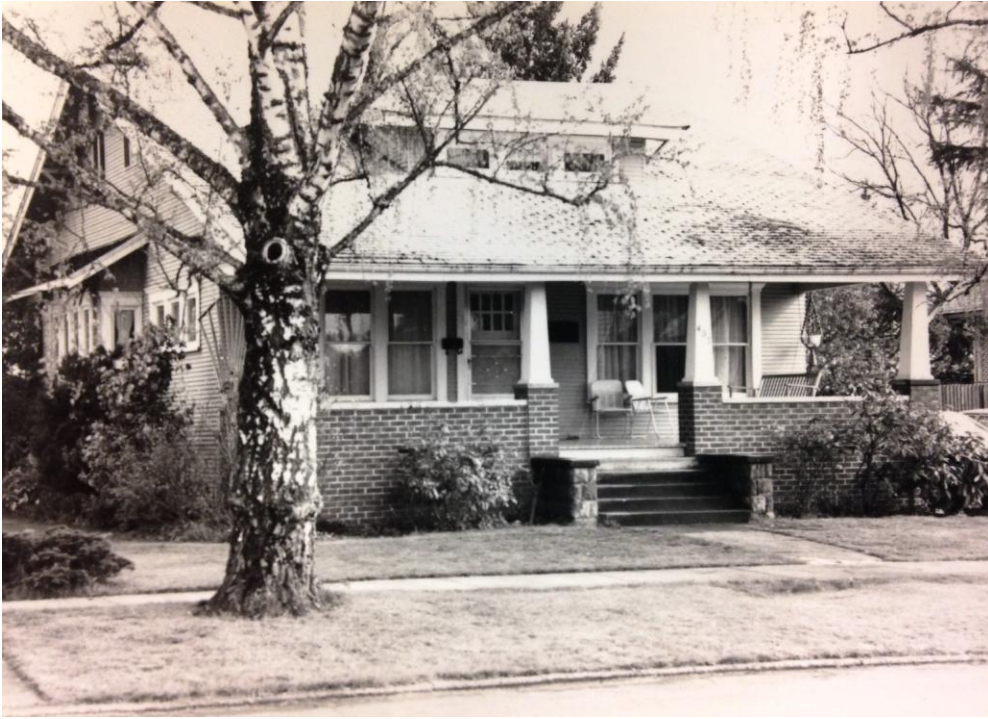
Original 1983 Survey Photo

The gabled roof of this bungalow extends to include the full front porch within its slope. Above a shed dormer lights the attic space. A shed bay is centered within the side (west, gable) elevation. Tapered wood (square) columns support the porch overhang and rest on (updated) birch piers connected by a solid birch wall to railing height. Low molded concrete block piers form the entrance steps. Double hung windows (single light) appear in groups of three, symmetrically on the front façade and irregularly on all others. Most of the bevel siding, window casing, doors and eave brackets are intact although there has been some window updating.
