**Historic Resources Survey
City of McMinnville
Yamhill County, Oregon**

729 NW Cedar Street

265

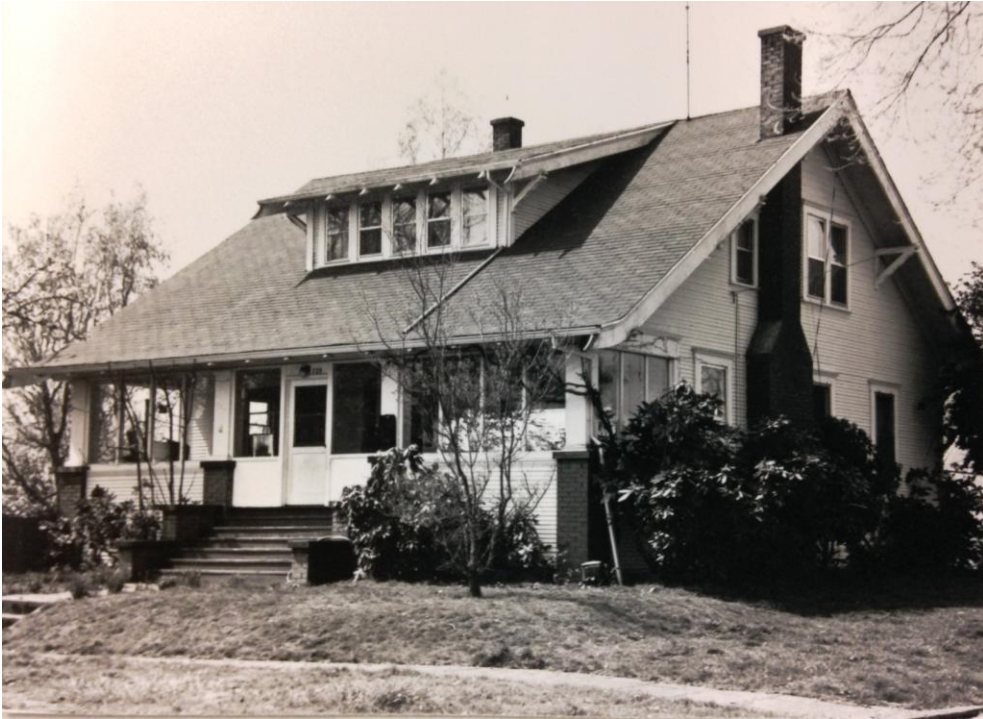
Historic Resource No. B265

Good

In need of paint.

Original 1983 Survey Photo
