**Historic Resources Survey  
City of McMinnville  
Yamhill County, Oregon**

907 NE Davis Street

**Historic Resource No. B371**

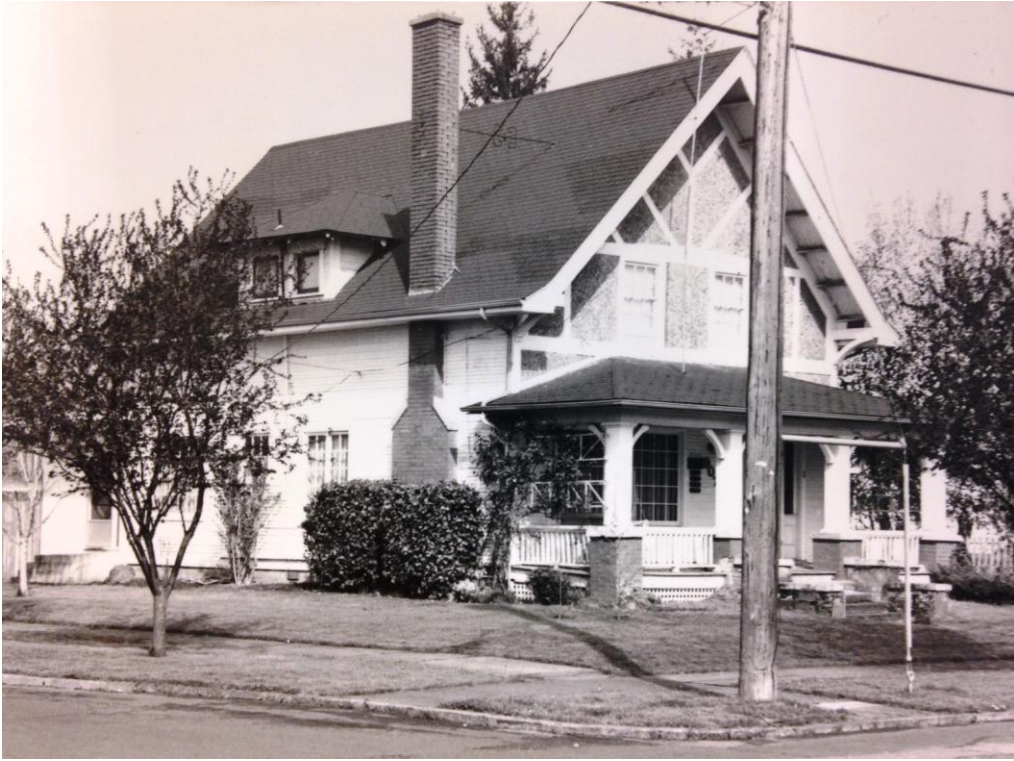
Original 1983 Survey Photo

Slight damage to porch steps; In need of paint.

The house needs paint; there is deteriorating brick work on the front steps. The balustrades on the porch need repair.
