Historic Resources Survey City of McMinnville Yamhill County, Oregon

Historic Resource Survey City of McMinnville Yamhill County, Oregon

B419

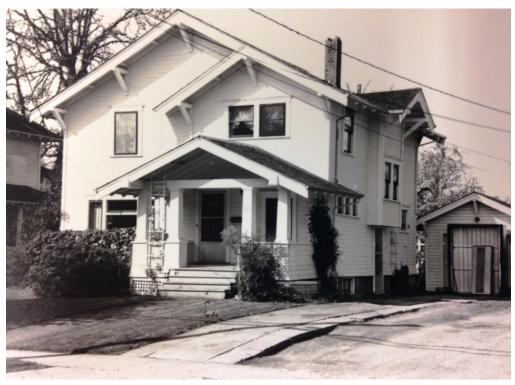
Historic Resource No. B419

A two story wood frame square bungalow with beveled siding. Medium gable roof with a second smaller gable on the façade. Part wood shingle in poor condition, part asbestos shingle. Full cement basement with north outside entrance. Some double hung windows with cornice moulding some casement. The off center gable roofed front porch has a central door with unbalanced window. Four pillars support porch roof. Steps and porch are of wood. There is a wood porch along back of house. Screens on all windows shut. Cement patio. Neat yard and landscaping. Center brick chimney.
