**Historic Resources Survey  
City of McMinnville  
Yamhill County, Oregon**

335 SW Baker Street

**Historic Resource No. B420**

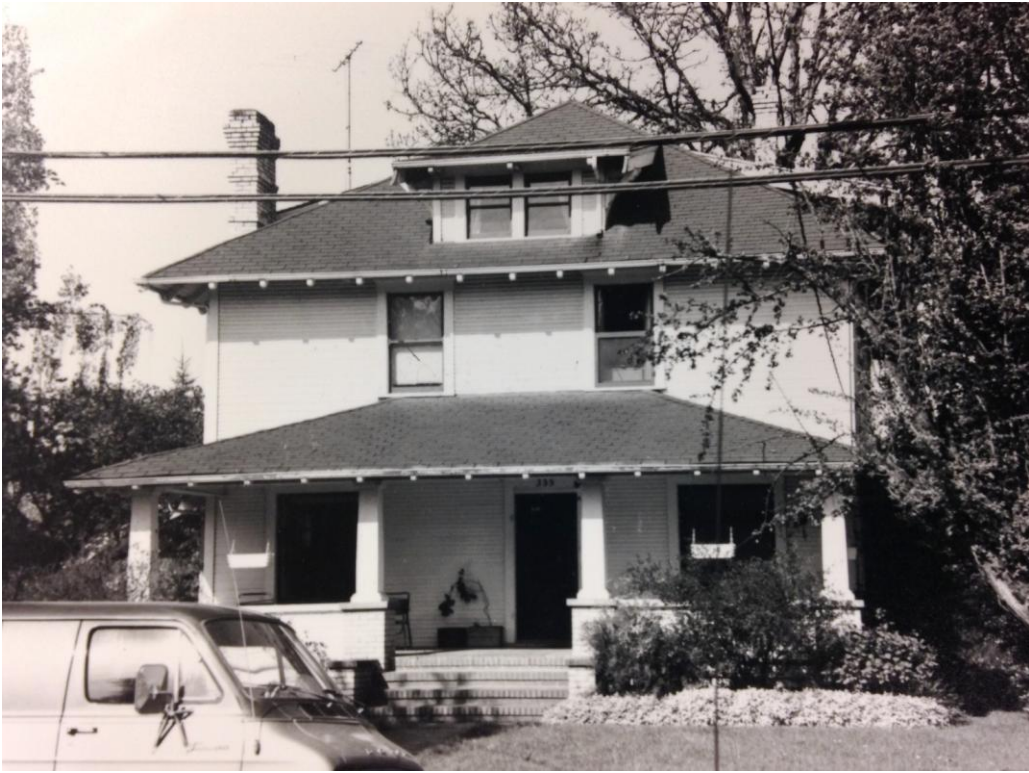
Original 1983 Survey Photo

Broken gutters or downspouts; In need of paint.

This is a two-story square house with hip roof and clapboard siding painted white. Brick steps lead to a four pillared, hip-roofed, wooden front porch extending the full width of the house. The hipped roof has asbestos shingles and eave brackets. The window treatment is double hung sash with cornice moulding. There are two shed dormers, one in front and one in the rear. There are two outside brick chimneys. On the south is a projecting bay with three double hung sash windows with cornice moulding. On the north is an enclosed side porch with 9/2 pane window and a door. The main entry door is central. The foundation is cement. The house is in fair condition; roof and gutters need repair. The landscaping is poor and yard is unkept.
