Historic Resources Survey City of McMinnville Yamhill County, Oregon

| Site Address | Own | wner at Time of Survey | | | | | | |
|---|---|---|---|---|---|---|---|--|
| 1430 NE Evans Street | | | Michael & Margaret Dressel | | | | | |
| S.S. Duncan House Residence | | | Residence | | | | | |

Historic Resource No. B629

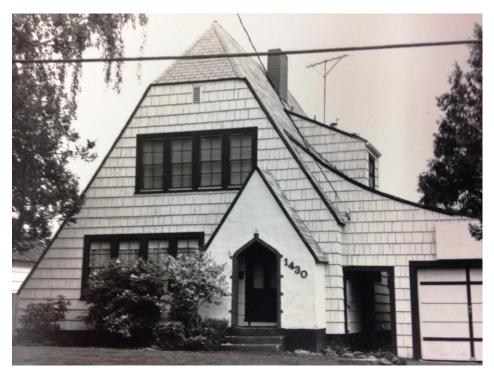
Original 1983 Survey Photo
