**Historic Resources Survey
City of McMinnville
Yamhill County, Oregon**

1025 NE Irvine Street

B692

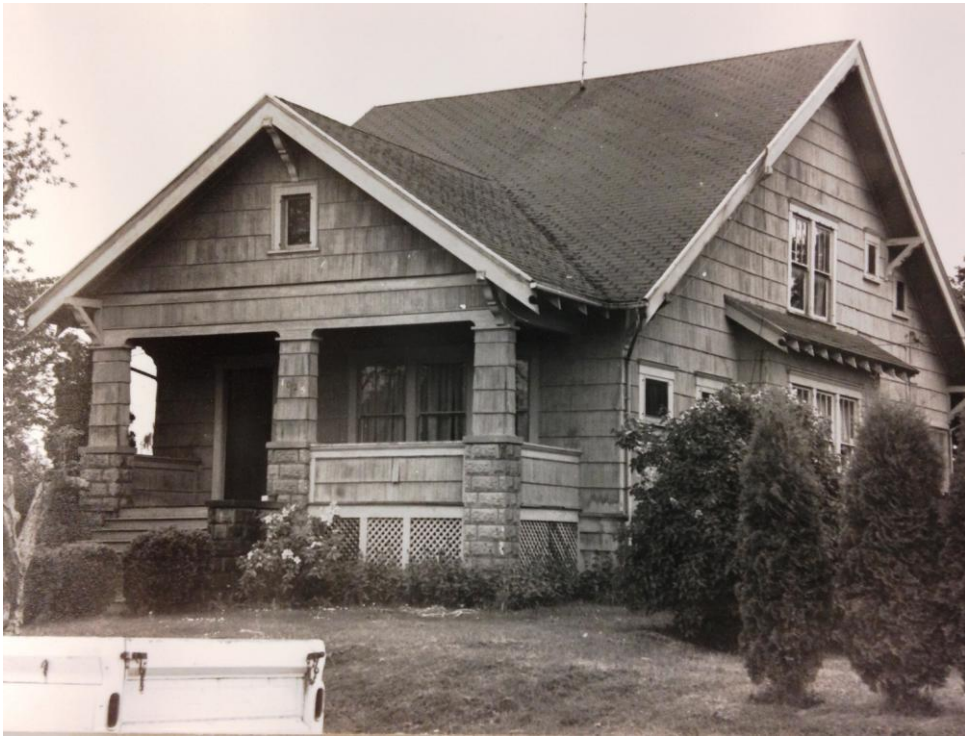
Historic Resource No. B692

Slight damage to porch steps;
Broken gutters or downspouts (some roof decay).

Original 1983 Survey Photo
