Historic Resources Survey City of McMinnville Yamhill County, Oregon

Historic Resource Survey City of McMinnville Yamhill County, Oregon

Historic Resource No. B73

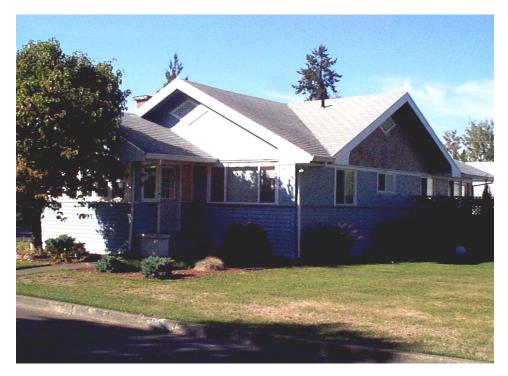
Photo October 2001

1.9	I-9		В	73					
Hist	oric I	nform	ation						
Date of ConstructionEaca. 1920Historic Name			Original Use		Unknown Common Name		Present Use		
		Resi	dence				Single-fami	ly Dwelling	
			401100	-			enigie iain	., D	
Condition of S	tructure	Comn	nents (at time of	Survey)					
Condition of S	tructure		nents (at time of damage to porch		need of	paint.			
	tructure	Slight	-			paint. ng Style	S	Stories	
Good	tructure	Slight (damage to porch	steps; In	Buildi			Stories	
Good Building Type Residential Porch Baser	nent R	Slight (damage to porch Dutbuildings Detached Garage Greenhouse	steps; In	Buildi	ng Style ngular Bung	alow 1	Stories	
Good Building Type Residential	nent R	Slight (((((((((((((((((((damage to porch Dutbuildings Detached Garage Greenhouse	i steps; In	Buildi	ng Style ngular Bung	alow 1	1	
Good Building Type Residential Porch Baser ✓ □	nent R	Slight (((((((((((((((((((damage to porch Dutbuildings Detached Garage Greenhouse R	i steps; In	Buildi	ng Style ngular Bung	alow 1	1
