**Historic Resources Survey
City of McMinnville
Yamhill County, Oregon**

406 SE College Avenue

B576 – Demolished 2005

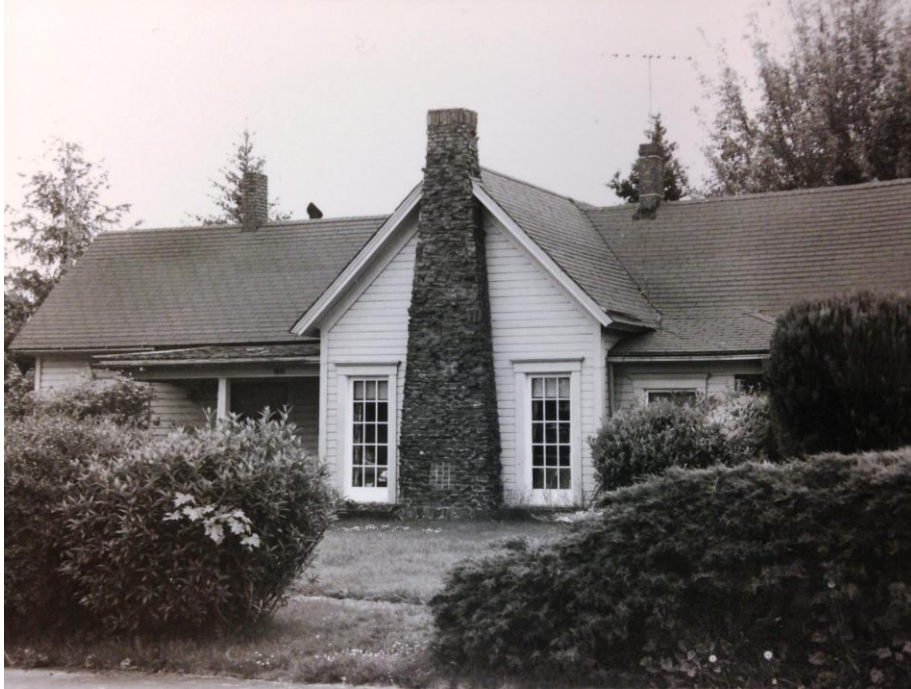
Original 1983 Survey Photo

This is a 1 ½ story, gabled, rectangular house with small gabled projections in front and rear (it is not a T-shape as these are not in line). It is vaguely reminiscent of an English country cottage. The roof is composition shingles with plain boxed cornices; siding is clapboard painted gold with white trim. It has a concrete foundation. Windows are sash and casement with molded trims. It is difficult to ascertain the main entrance as it is on a corner with the gable façade on one street and the main on the other. On the main façade street side there is a porch with an off-center door and port of the house's gable roof. It has plain wood columns for support. On this side is also the most outstanding feature: the rough stone chimney flanked by what appears to be fixed window casement with 15 lights in each. There is another central brick chimney as well as small added-on hooded back porches on the opposite side (from street). It has an unattached garage in the rear. This house is in need of general upkeep and repair. The plantings, while nice, are overgrown and a lot of the wood looks to be rotting, especially the porch on the chimney side, which is also sagging. It is still, however, a very charming and quaint house.
