## Historic Resources Survey City of McMinnville Yamhill County, Oregon

Site Address			Owner at Time of Survey					
1034 NE Galloway	St.		Paul & Glori	a Martir	nis			
Map/Tax Lot Curre		rrent Zoning	Special Tax Assessment			Downtown Historic District		
R4416CD12600 R-3		3	No		No	No		
Subdivision Name			Block	Lot	Lot Siz	e Qua	drant	
Oak Park Addition			33	4	5,000 s	sq.ft. NE		
Site Number Aerial Number Resource Classificat		Resource Classification	Resou Numbe		Historic Significance

### **Historic Resource No. A668**

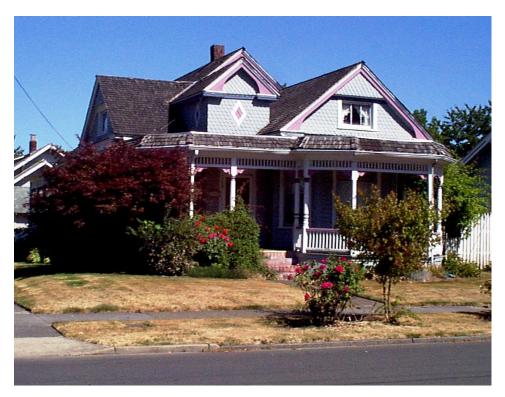
Photo July 2001

This one-story Queen Ann hip roof house with gabled bays has a flat-roofed (Mansard) cornice veranda which follows the various projections of the front elevation (west). A side (north) service porch is of similar design but within the main roof structure. The plan is near Latin cross yet the west bay is off-center to the south. The north and west bays have 45 degree corner angles with a single narrow double hung window in each. A wide double hung window is centered in each bay. Other windows are double hung (all single light) in irregular arrangement. The gable ends have boxed cornices with verge boards cut to form pointed arches. Within the walls are surfaced with cedar shingles in various patterns: i.e. fish scale, diamond, and straight. The roofing is also cedar shingle. The remainder is sided with sixinch drop siding with vertical boards below the watertable and porches.

The porches are highly detailed with a single balustrade and frieze stick work. They have turned supports with scroll cut brackets and wood flooring. A rear (east) door has a hip roof canopy of similar design. Door appears original and the windows have cornice molding.

The house is on a concrete foundation and is in excellent condition. A neighbor recollects that this house was moved from Fourth and Ford Streets in the mid-1940's.
