**Historic Resources Survey  
City of McMinnville  
Yamhill County, Oregon**

736 NE Galloway St.

**Historic Resource No. A772**

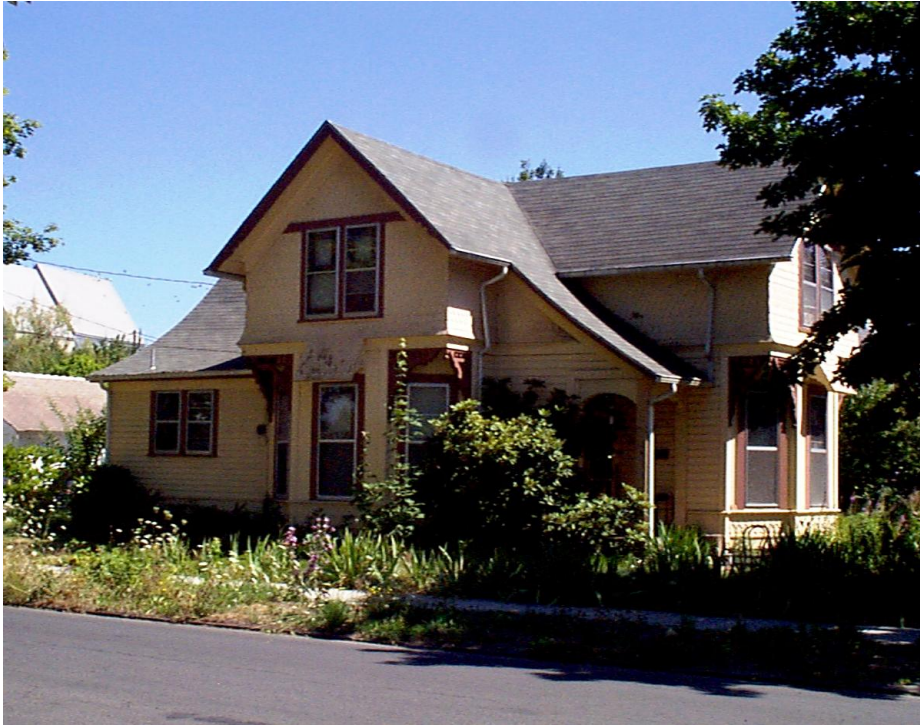
Photo July 2001

This rather restrained Queen Anne house occupies a corner lot and faces west and north. It is a two-story irregularly shaped cross with a cross-gabled roof. The gables of the north and east elevations each slope to a wide flare on the side. Verge boards display very restrained sawn decoration. Ornamental shingles cover the flared upper story on the south, west, and north elevations. The remainder of the siding is narrow drop with corner boards. Shingled hoods extend from the flared second story overhang over the central first floor windows of the gables on the west and north elevations.

First floor corners under the gables on the west and north are cutaway to form bays; pendils and decorative sawn work superimpose the windows in these bays. A porch is tucked under the roof extension on the north elevation; it is supported by plain posts and has a simple balustrade. Fenestration is irregular; all windows are double-hung, one over one sashes, those on the second floor paired and having the typical small Queen Anne colored lights surrounding the main upper light. The low foundation appears to be brick.
