## Historic Resources Survey City of McMinnville Yamhill County, Oregon

B10 1755 NW Baker Creek Road

## Historic Resource No. B10(B11 Barn) Demolished 2002

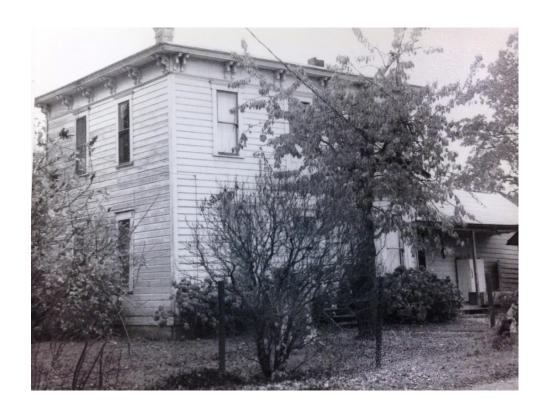
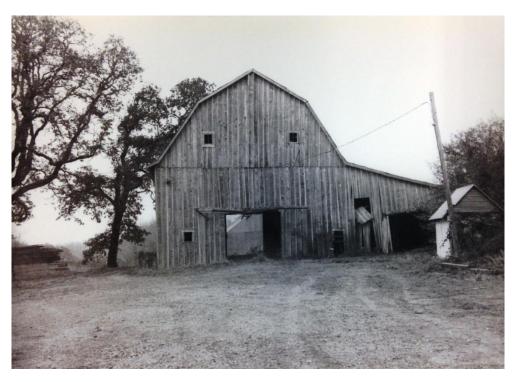
This is a two story Italianate box, with flat hipped roof on paired decorative brackets and a wide frieze. Regular narrow 1/1 windows have architrave mouldings, and there is an Italianate bay window on the first floor east side. There are traces of a former porch on the center east side, a narrow central door over the first story door. Both doors have transoms and architrave mouldings. The upper has four lights and recessed panels, the lower has recessed panels only. Siding is novelty or drop siding with corner boards. The chimney is just off center. A one-story sloping gable roofed porch is attached at the rear and small shed is connected t this addition. Main house has a concrete foundation. The barn is a gambrel roofed dairy barn with board and batten siding. It is near collapse.

Original 1983 Survey Photo
