Historic Resources Survey City of McMinnville Yamhill County, Oregon

Site	Information							
Site Address		Ov	Owner at Time of Survey					
235 NE Dunn Place	9	0.	E. & L.L. I	Full				
Map/Tax Lot Current Zoning		9				Downtown Historic District		
R4422CD01700	R-2 PD		No		No			
Subdivision Name			Block	Lot	Lot Siz	ze Qua	adrant	
Martin D.L.C.						NE		
Site Number A	erial Number Resource Classifica	-	Resour Number		Historic S	ignificance

B1125 – Demolished 1999

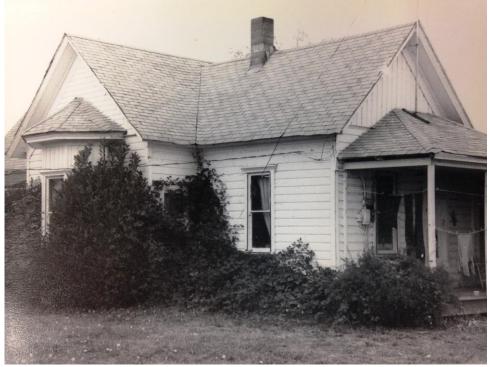
Original 1983 Survey Photo

This one-story rural vernacular house has a greek cross plan and a cross-gable roof. The roof, a medium pitched gable, has boxed cornices, plain frieze, and simple moulding. A plain block interior chimney pierces the ridgeline. An Italianate bay window faces Three Mile Lane, as does a porch on turned posts on the west wing. The other porch on the east end consists of a hipped roof on plain 4×4 posts.

The roof has boxed cornices, plain frieze and simple moulding. The siding is horizontal "novelty" siding, with vertical siding or shingles in gables. Windows are typically one over one, with cornice moulding. The bay window has a hipped roof and vertical siding. There is no basement. The interior has been extensively remodeled.

The east section of this structure is a replacement of one which collapsed, according to the owner. The owner also states that a small outbuilding was originally used as a vegetable and fruit cellar.
