## Historic Resources Survey City of McMinnville Yamhill County, Oregon

## B270

## Historic Resource No. B270

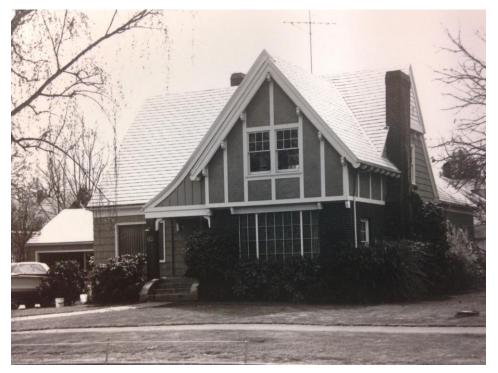
This Norman farmhouse style home sits on a corner lot squarely in a north-south orientation. It is T-shaped. The dimensions are 48' x 70'.

There are four rather steeply pitched cross gables with one sloping flaring over the side porch. It appears to be aluminum. The walls are composed of a variety of materials, brick, shakes, and stucco embellished with narrow vertical boards, imitative of half-timbering. There is a cement basement. The side porch is supported by a brick post. There is a variety of windows but most are double-hung sash with six lights on the top half. The large front window has thirty-six lights – eight on each side of twenty separated by a mullion. There is an exterior fireplace chimney. The eaves project and there are exposed rafters and brackets. The shape of the house is asymmetrical.

Original 1983 Survey Photo
