Historic Resources Survey City of McMinnville Yamhill County, Oregon

Historic Resource No. B32

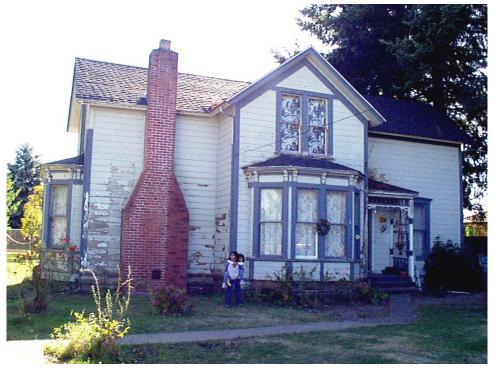
Photo October 2001

The house is Latin cross shaped with a high gable roof which has boxed cornices, wide frieze and moulding. The house is sheathed in wide drop siding with cornerboards. Gables have fish scale shingles down to the top of paired second story windows. Windows are typically 1/1 double hung sash. On single windows, a small pediment tops the otherwise plain moulding. There are Italianate bay windows in the north and east sides with hip roof supported on ornate small consoles and a frieze with recessed panels. A small front stoop has hip roof supported on turned decorative posts with open spooled lintel and decorative bracket. The porch has a wood rail and ornate balustrade.

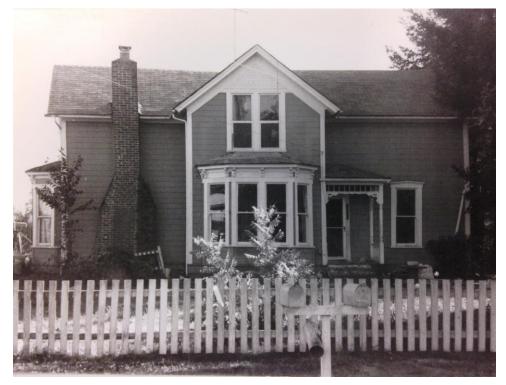
Original 1983 Survey Photo

Resident says former owner, now deceased, told her the house was built by a retired sea captain for his young bride. A section was added in 1940, as an apartment. The house was further remodeled and converted into a retirement home. A fireplace was added in the 1950's. The exterior retains its integrity despite interior alterations.
