Historic Resources Survey City of McMinnville Yamhill County, Oregon

Historic Resource No. B332

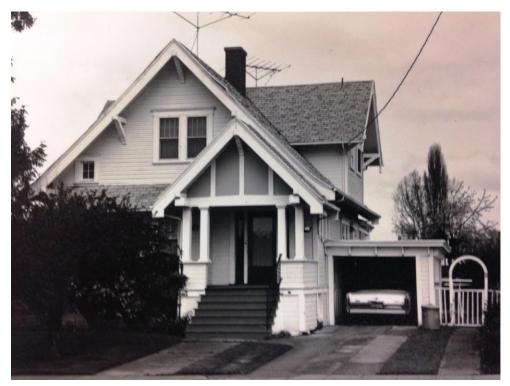
A two-story bungalow with bellcast gable roof with roof brackets under rake two gable dormers with brackets under rake. Each dormer has two double-hung sash windows with cornice moulding. A bay on the west side has three windows, one over one double-hung sash. The front window is protected.

The basement is half daylight with wood water table. The siding is bevel with corner boards. There is a central chimney. The entrance is within a gabled off-center porch. The door is a full window with full length side lights. The porch gable is decorated with vertical boards and stucco, to simulate half timbering. A flat-roofed attached garage may have been added later. A harmonious addition to the back of the house was done in 1940 by Bill Odell. The dining room ceiling has exposed wood beams.

Original 1983 Survey Photo
