Historic Resources Survey City of McMinnville Yamhill County, Oregon

Site Address 326 NE 6th Street				Owner at Time of Survey Del Coursey & Jim Stanard					
									Map/Tax Lot
R4421BC01100		C-3		No	No		No		
Subdivision Name				Block	Lot	Lot Siz	e Qu	ıadrant	
Court Addition				1	_2	7,250 s	sq.ft. NE	<u> </u>	
Site Number Aerial Numb		Number	mber Resource Re Classification Nu		rce er	Historic S	Historic Significance

5.24	<u>J-10</u>	-10 B		365		Primary Re	Primary Resource #107		
Hist	oric	Inform	ation						
Date of Constr	uction	Early Ad	ditions/ Remo	dels Build	er/Arch	itect			
ca. 1890		Rem'l to house ca. 1900		Unkn	Unknown				
Historic Name		Original Use		Commo	Common Name		Present Use		
Hodson Barn; Turner House		Barn			Residence				
Condition of S	tructure	e Comn	nents (at time	of Survey)					
Good									
Building Type		Outbuildings			Build	ing Style	Stories		
Residential		Attached Garage		ge	Italianate		2		
Porch Basen ✓	nent	Roof Style Hip		Roof Type		Moved	Demolishe	ed Year/Date	
Permit Number	r(s)	Addition	s/ Alterations						
99B0976		Replace	Replace Deck						
Resc	ource	Inforr	mation						
Recorded By			Dat	e	Source	es			
Jan M. Bennette			7-30	0-1980		y Gunness; L

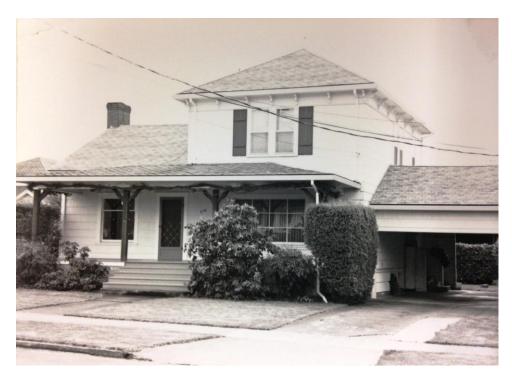
This two-story Italianate hip roof home has a one-story east facing gable wing with brick chimney piercing the gable end. Probably built in 1885.

The roof covering is of newer composition shingles in excellent condition and the roof forms a slight overhang with curved bracketed supports. The exterior of the home is then, plain, wood shakes, also in good condition.

Forming a carport on the west side is a smaller end facing gable roof with squared support columns on rear only and extending from that gable is a flat roof addition acting as a cover now for a wood storage area somewhat destroying the architectural integrity. A rear facing shed roof extension on the east side has also probably been a later addition and is not in keeping with the architecture.

The structure sits on a concrete foundation and seems to be in excellent condition; probably housed a basement.

The one-story wing houses the front entry, and the roof forms the porch covering extending across the front of two-story portion. The shrubbery is now covering the lower window second story portion.

Original 1983 Survey Photo
