## Historic Resources Survey City of McMinnville Yamhill County, Oregon

Historic Resource Survey City of McMinnville Yamhill County, Oregon

## Historic Resource No. B486

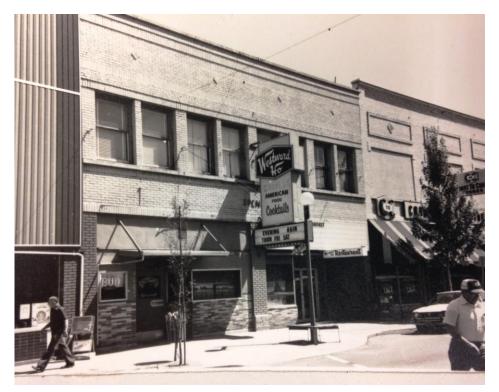
The building is a simple brick structure, two stories high, facing south on Third Street between Davis and Evans. Four pairs of plain recessed double-hung one-over-one sash windows stretch across the façade at the second story level. The roofline is straight and only slightly defined three courses of common bond, and diminutive raised diamond shapes make up the modes ornament. The ground floor of the façade has two storefronts and a wide uncovered stairwell opening. Stucco, contemporary brick, and aluminum windows of varying sizes have altered and interrupted the cohesiveness.

Original 1983 Survey Photo
