## Historic Resources Survey City of McMinnville Yamhill County, Oregon

28.0 <u>J</u> -	0 <u>J-11</u> <u>B</u>		489		Secondary Resource #208.1		3.1	
Histor	ic Inform	ation						
Date of Constructi	on Early Ad	ditions/ Remod	lels Builde	er/Archit	ect			
ca. 1912-1928			Unkno	wn				
Historic Name Original Use		inal Use	Common Name Present Use					
Lark Theater	Thea	Theater		Coast to Coast Comme				
Condition of Struc	ture Comn	nents (at time o	of Survey)					
Good	Small	cracks in walls,	chimneys.					
<b>Building Type</b>		Outbuildings		<b>Building Style</b>		Stories		
Commercial		None						
Porch Basemen	t Roof Style		Roof Type		Moved D	Demolished	Year/Date	
Permit Number(s)	Addition	ns/ Alterations						
97B0443, 97B0784, 03B0410	Interior (	Commerical Ren	nodels					
Resou	rce Infori	mation						
Recorded By		Date	•	Source	5			
Jancie Rutherford		7-16-	-1980	Sanborn	Maps, McMinr	nville 1912 & 1	928	
Jancie Rutherford		7-16-	-1980	Sanborn	Maps, McMinr	nville 1912 & 1	928

## **Historic Resource No. B489**

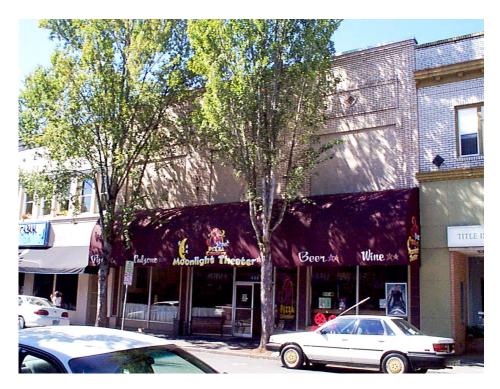
Photo August 2001

This building faces south midblock on Third Street between Davis and Evans Streets. The parapet wall of the façade is of buff-colored brick, has a straight, corbelled roofline and restrained ornament of raised brick panels and diamonds. Tiers of raised brick articulate either side of the façade. Three openings across the façade have been blocked or stuccoed over. The ground floor storefront has one central opening, flanked by large aluminum framed windows. An awning stretches the full width of the façade. The rear elevation which faces an alley is slightly gable, is of concrete, and has openings.

The building was once a theater. The ceiling has been lowered for commercial use.
