Historic Resources Survey City of McMinnville Yamhill County, Oregon

Site Address Ow			wner at Time of Survey				
344 SW Bills Street		Gladys Wer	Gladys Wendling & Betty Hyde				
Map/Tax Lot Current Zonin		•	Special Tax Assessment		Downtown Historic District		
R4420DA07700 R-2		No	No		No		
Subdivision Name		Block	Lot	Lot Size	e Quad	rant	
Cozine's 2nd Addition			18	5,629 sc	q.ft. SW		
Site Number Aerial Number Resource Classific			Resource Historic Si Number			gnificance

Historic Resource No. B498

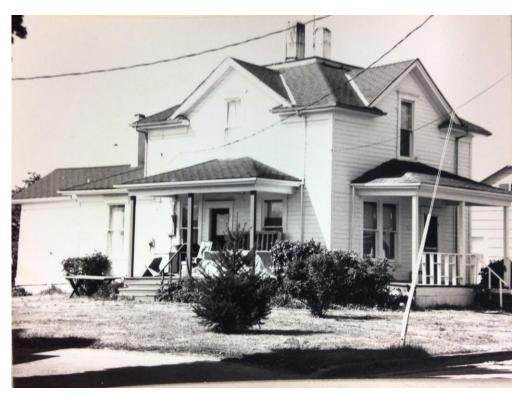
This house is a two-story wood frame construction with concrete foundation. The roof is cross gabled with returns, the main part being a truncated hip type. The windows are tall, narrow and double hung, one light over one. The two porches, one north in front of the house, and one east, have one-story hipped roofs, wooden floors and steps, and plain round wooden posts. The house is basically square, but has a one-story back extension with hipped roof. There is a gabled extension off of that which appears to have only wooden blocks under it for foundation support. It is sagging and shows much more age, due to its construction features, than the main part of the house.

There are two chimneys rising from the center of the house, and one from the gabled extension in the rear. The house has plain corner boards and frieze boards.

Original 1983 Survey Photo
