**Historic Resources Survey  
City of McMinnville  
Yamhill County, Oregon**

<b>Site Address</b>		<b>Owner at Time of Survey</b>			
505 NE 8th Street		George R. Hibbs			
<b>Map/Tax Lot</b>	<b>Current Zoning</b>	<b>Special Tax Assessment</b>	<b>Downtown Historic District</b>		
R4421BB09200	R-4	No	No		
<b>Subdivision Name</b>		<b>Block</b>	<b>Lot</b>	<b>Lot Size</b>	<b>Quadrant</b>
John's Addition		19	5	12,000 sq.ft.	NE
<b>Site Number</b>	<b>Aerial Number</b>	<b>Resource Classification</b>	<b>Resource Number</b>	<b>Historic Significance</b>	
17.4a	K-10	B	720	Primary Resource #323

**Historic Resource No. B720**

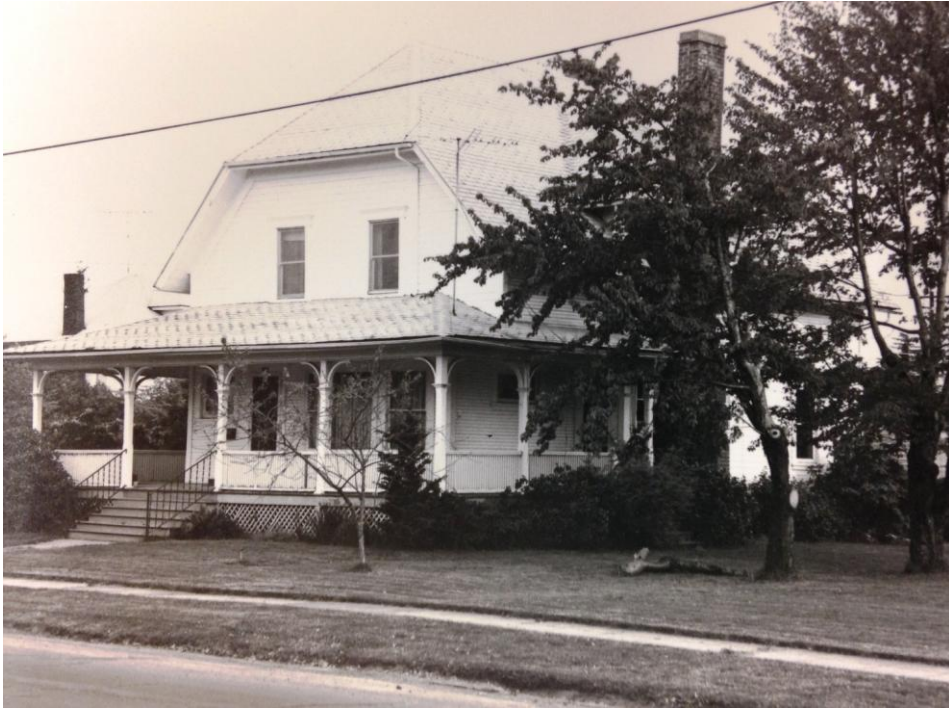
This house sits on a corner lot facing south, it is a two-story rectangle with jerkin-head roof and hip-roofed wall dormers central to each side elevation. Siding is narrow, V-grooved, and the foundation is brick. A wide elevated front porch wraps part way around either side, has a balustrade, and is supported by chamfered square columns with capitals and curved support brackets.

Eaves are plain as are frieze and rake boards and corner boards. There is a one-story, hipped roofed, first floor oriel window on the west elevation matched by an off-center bay on the front porch. Both have leaded glass upper sashes in the center windows. The east elevation has an outside chimney and the rear, a hip-roofed off-center screened porch decorated with arched openings, capiteled posts, and lattice work.

Fenestration is irregular but most windows are double hung sash with wide casing and cornice moulding.

Original 1983 Survey Photo
