# Historic Resources Survey City of McMinnville Yamhill County, Oregon

#### B767

## **Historic Resource No. B767**

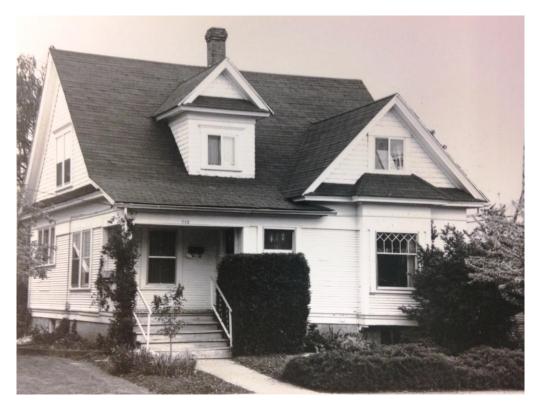
This two-story, basically square-shaped home has a cross gable roof of asphalt shingles with a pediment dormer. The siding is coved, the foundation is cement. There is a full basement with outside cellar steps on the west side.

The window treatment is double hung sash with shelf, front leaded. On the west side are two projected squares with decorative brackets enclosing large windows. There is a one pillared front porch with an off center oblong glass door with beautiful brass hardware. The brass doorknobs are throughout the house.

There is a small rear porch enclosed with cross slats. Single car garage. One center brick chimney.

Original 1983 Survey Photo
