## Historic Resources Survey City of McMinnville Yamhill County, Oregon

## **Historic Resource No. B841**

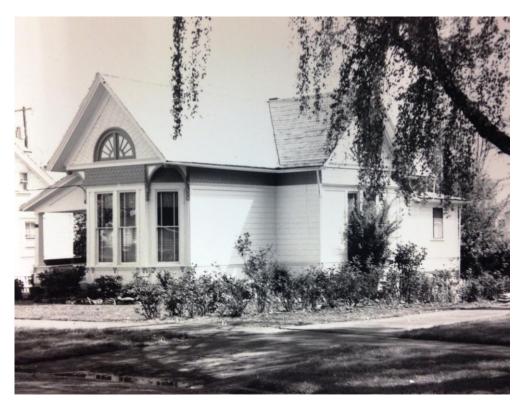
This very neat and well kept one and one half story white wood frame house with yellow and gold trim was constructed in a rural vernacular T-shaped with some Queen Anne features. It has a low red brick foundation covered with plaster. Above that is a plain wood water table. Basically, it has novelty siding and a gabled roof and an interior chimney.

One immediately notes the large bays on the façade (west) and north elevation. They each contain four one over one double hung sash windows. Under the pilasters of each bay is panel breeze board in an imbricated pattern. Over the windows of each bay is a painted, fan-shaped arched window. Other decorative features of the house include siding right under the gabled roof line which consists of alternate rows with staggered ends. The house has boxed cornices with brackets and especially decorative frieze over side windows of both bays. There is diagonal siding all the way around over the water table. We suspect that the porch (front) is an addition as is an ell on the rear. The landscaping is attractive and well tended.

Original 1983 Survey Photo
