## Historic Resources Survey City of McMinnville Yamhill County, Oregon

## Historic Resource No. B872

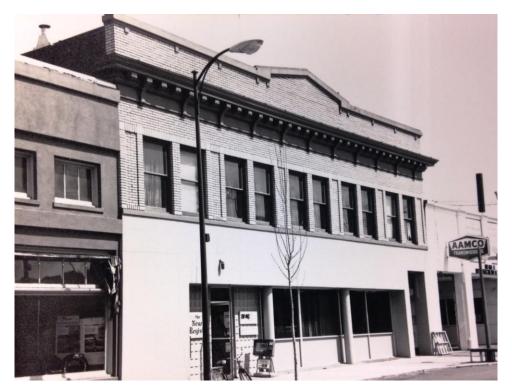
Original 1983 Survey Photo

This is a square brick two story structure situated middle block between Ford and Galloway facing south on Third Street. The façade is five bayed, the second story windows being one over one double hung sash, paired, each pair articulated by rows of stretchers. A prominent bracketed and modillioned cornice line stretches the length of the façade above these windows. A parapet wall with a central gable rises three feet above the cornice line. The façade is faced with common bond buff brick above the first floor. Extensively altered, the first story of the façade is faced with scored stucco and ahs been cutaway to expose two pillars. A stairwell opens onto the street at the extreme east end. The building has been joined to another at its rear which faces Fourth Street on the north. In 1928, the building housed a garage.
