**Historic Resources Survey  
City of McMinnville  
Yamhill County, Oregon**

137 SE Galloway Street

**Historic Resource No. B882**

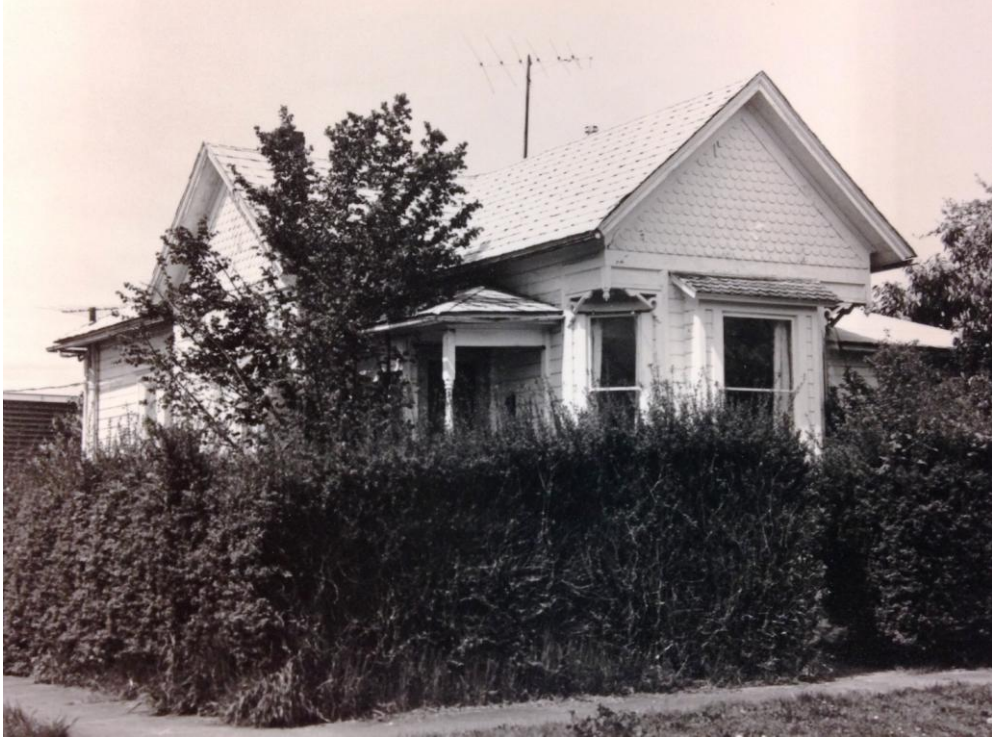
Original 1983 Survey Photo

Slight damage to porch steps; Broken gutters or downspouts; In need of paint; Rotten sills or frames.

Corner lot. Small Queen Anne house nearly hidden by high, unkept hedge. Cross shaped gables on sides and a bay in front with fish scale shingle trim in gable end. Bracketed corners enclose three double hung windows of bay which has a shed roof over center windows. Small entry porch on left has wooden floor and steps. A wing on the back has a hip roof. Shingles are asphalt, vertical boards cover a high foundation and a water table divides house from foundation. The house is in rather poor condition.
