**City of McMinnville
Planning Department**

Historic Landmarks Committee Hybrid In-Person & ZOOM Online Meeting Thursday, October 27, 2022 - 3:00 PM McMinnville Civic Hall: 200 NE 2nd St.

DATE: October 27, 2022
TO: Historic Landmark Committee Members
From: Adam Tate, Associate Planner
SUBJECT: HL 4-22 (Certificate of Approval for Alteration) – 935 NE Galloway Street

- DOCKET: HL 4-22 (Certificate of Approval for Alteration Resubmission)
REQUEST: Applicant is requesting the approval historically accurate repairs including the replacement of windows, roofing, and siding in order to restore the home from its current state of disrepair, as well as adding a new dormer to the rear roof.
LOCATION: 935 NE Galloway St, also known as Tax Lot R4421-BB-06900
ZONING: R-3 (Two-Family Residential Zone)
APPLICANT: Daniel Bramske
STAFF: Adam Tate, Associate Planner
DATE DEEMED COMPLETE: August 5, 2022 (Original) October 3, 2022 (Resubmission)
REVIEW BODY & ACTION: McMinnville Historic Landmarks Committee
MEETING DATE & LOCATION: October 27, 2022. This will be a hybrid meeting, in person at McMinnville Civic Hall 200 NE 2nd St and online via Zoom. Zoom Online Meeting ID: 862 6355 6395, Meeting Pa

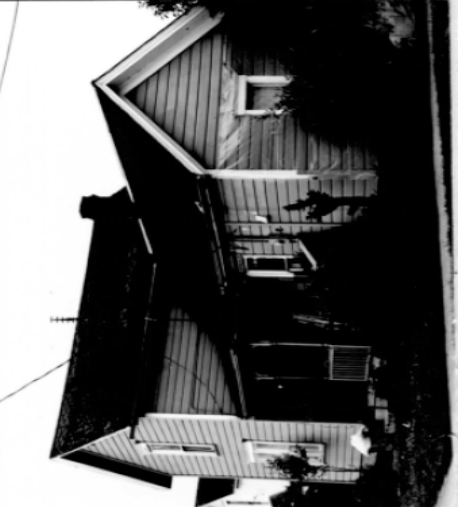
Figure 2. Entry NO. B662 on the McMinnville Historic Resources List

Site No. 21.7 Aerial Map K-9
Block 29 Lot 4
Addition Oak Park
Tax Lot 4421 BB 6900
Address 935 NE Galloway OK
Common Name -
Historic Name -
Present Owner Cecilie and Yolanda Suarez
Present Use Residence
Original Use "
Builder or Architect unknown
Outbuildings garage (west property line)
Date of Construction c. 1895
-Condition Assessment on Reverse Side-

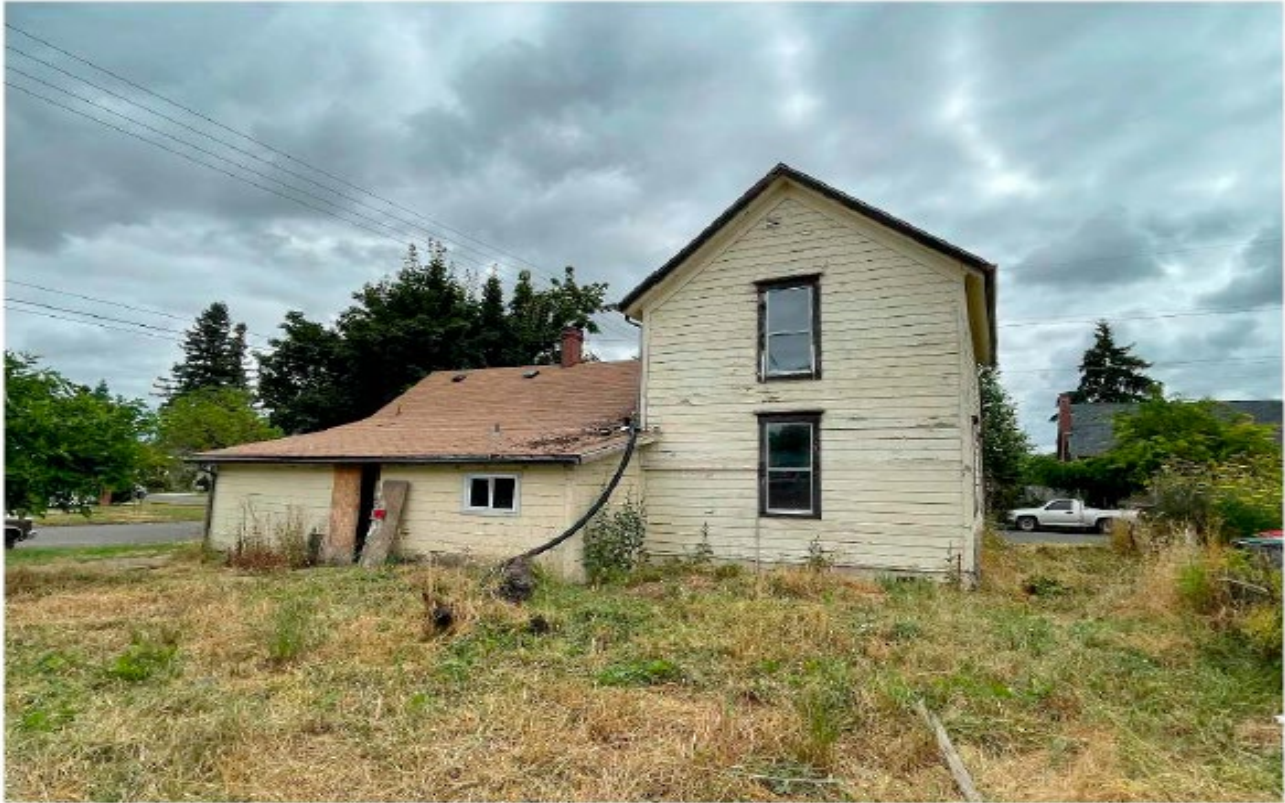
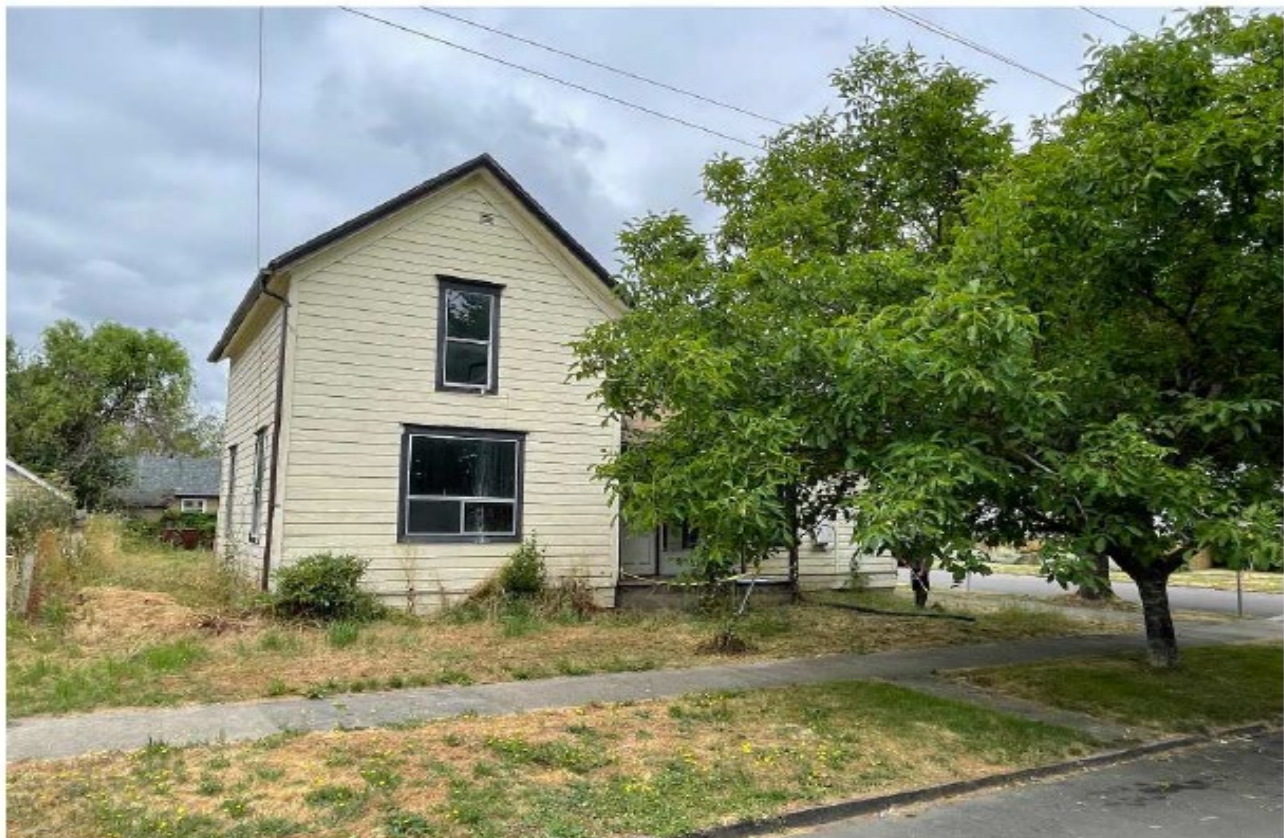
Figure 3: Photos of Current Exterior Conditions

The applicant plans to replace rotted siding with new wooden siding as well as remove the period incorrect aluminum windows, and replace them with period correct wooden windows. The applicant also plans to repair the front porch and its railing with new wood designed to match the historic design of the home. They also plan to repair the rear of the shed roof and add a new dormer there. The electrical meter will also be rerouted to the rear of the home from its current location in the front in order to enhance the historic character of the home.

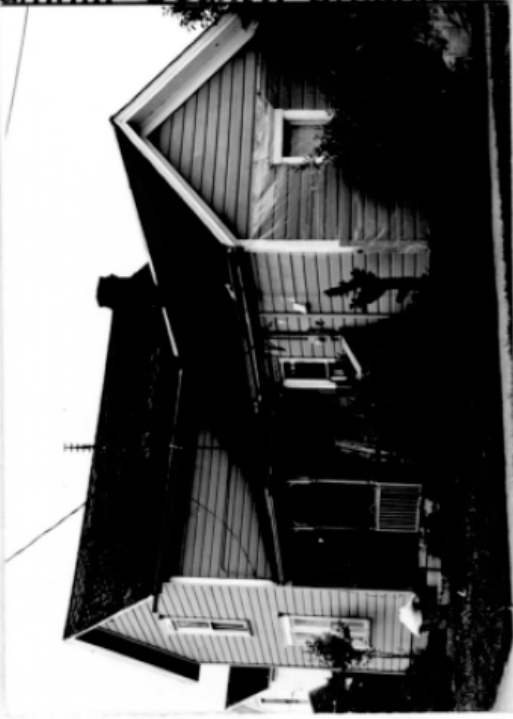
Figure 2: Entry on City of McMinnville Historic Resources Inventory

Site No. 21.7 Aerial Map K-9
 Block 29 Lot 4
 Addition Oak Park
 Tax Lot 4421 BB 6900
 Address 935 NE Galloway OK
 Common Name -
 Historic Name -
 Present Owner Cecilio and Yolanda Suarez
 Present Use Residence
 Original Use "
 Builder or Architect unknown
 Outbuildings garage (west property line)
 Date of Construction c. 1895
 -Condition Assessment on Reverse Side-

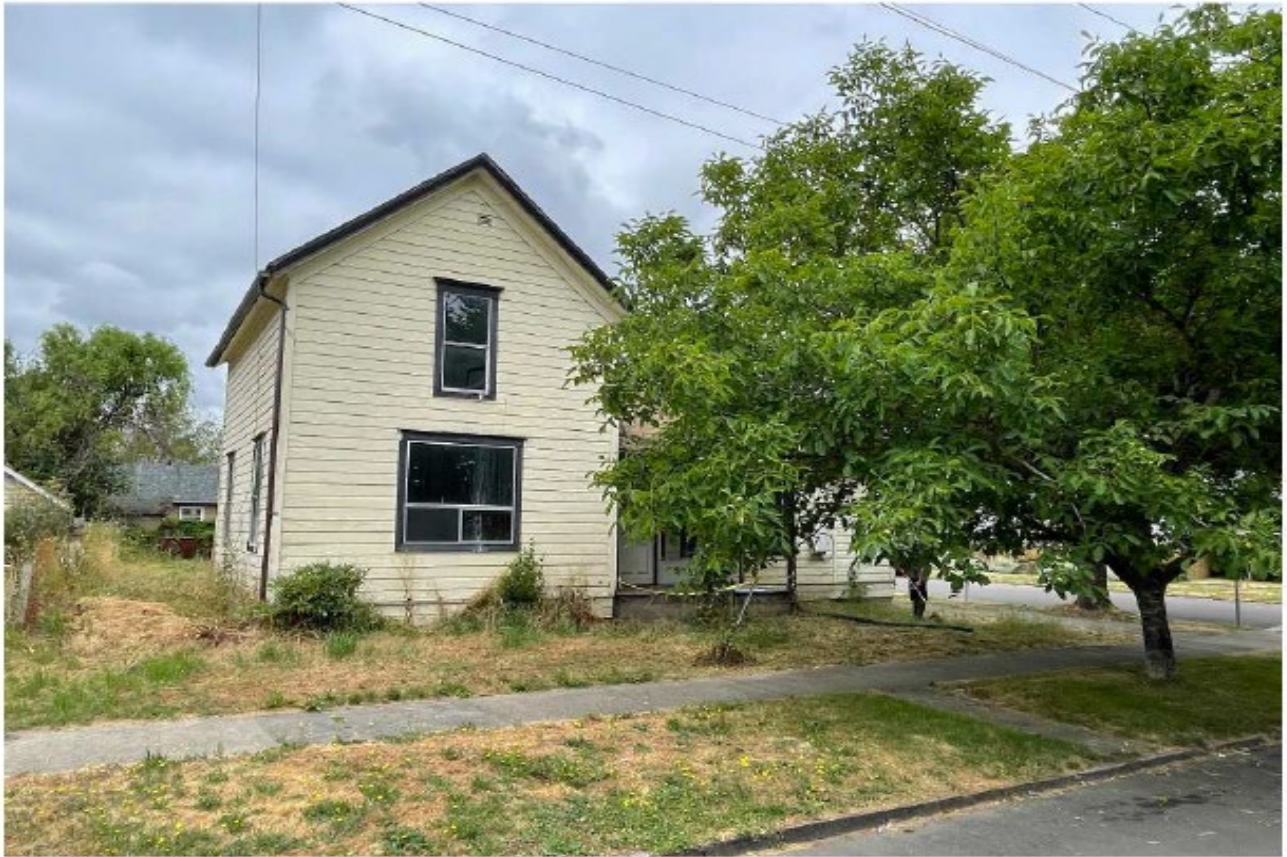
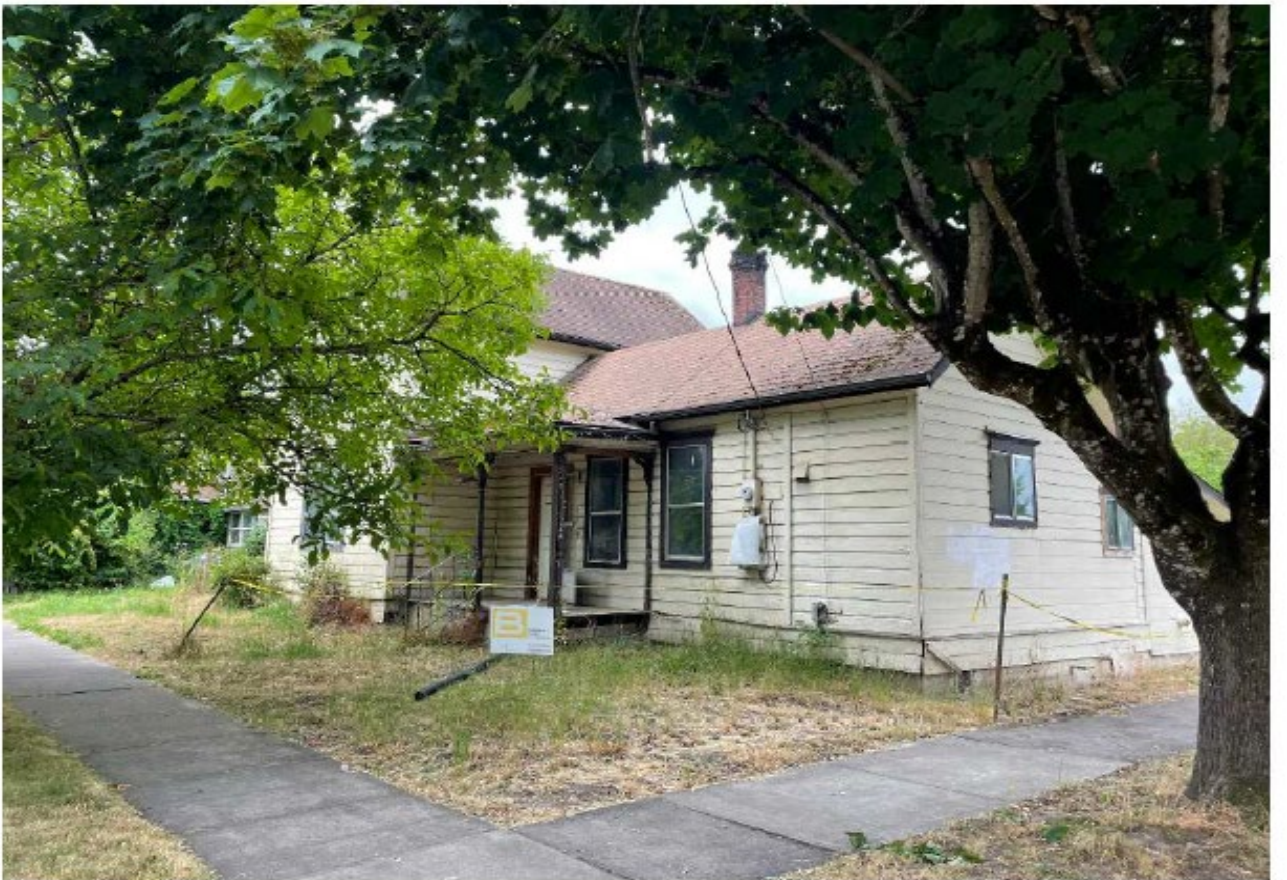
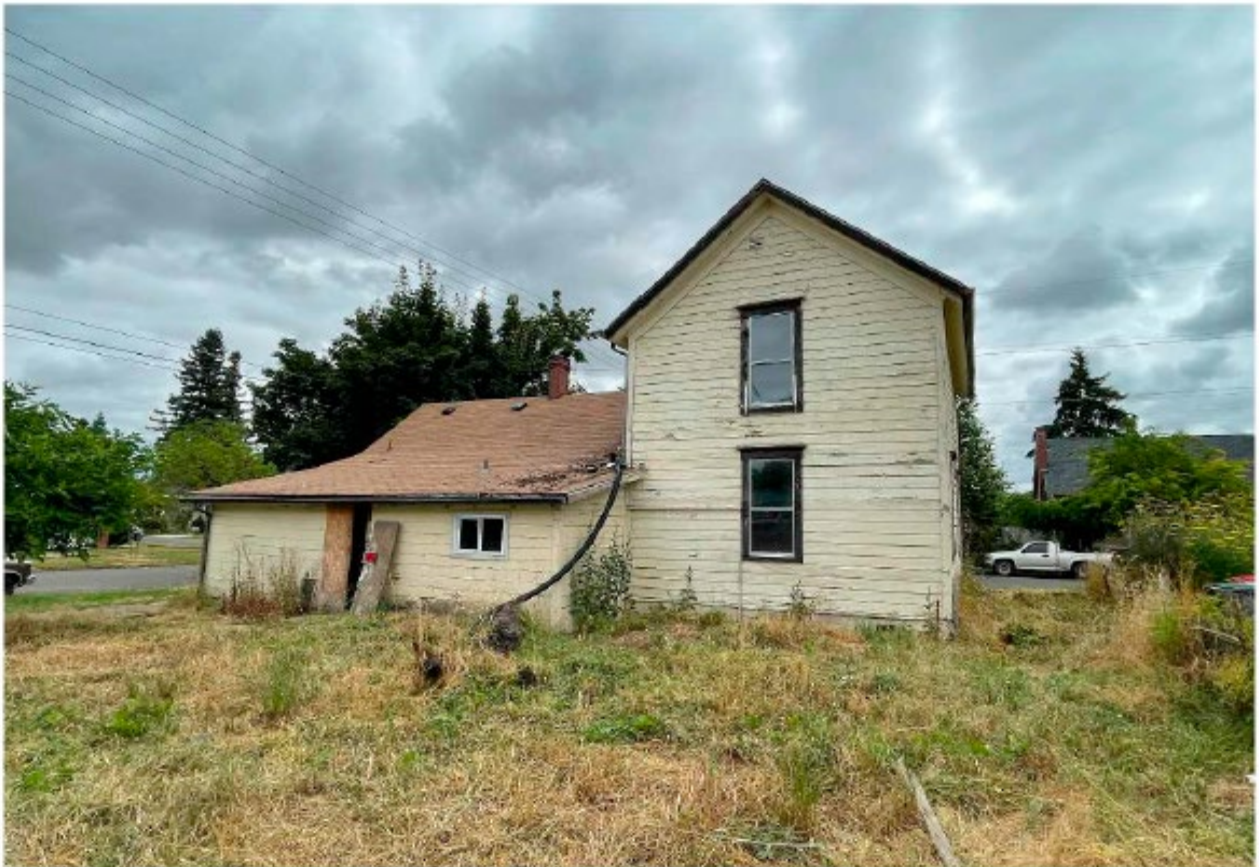
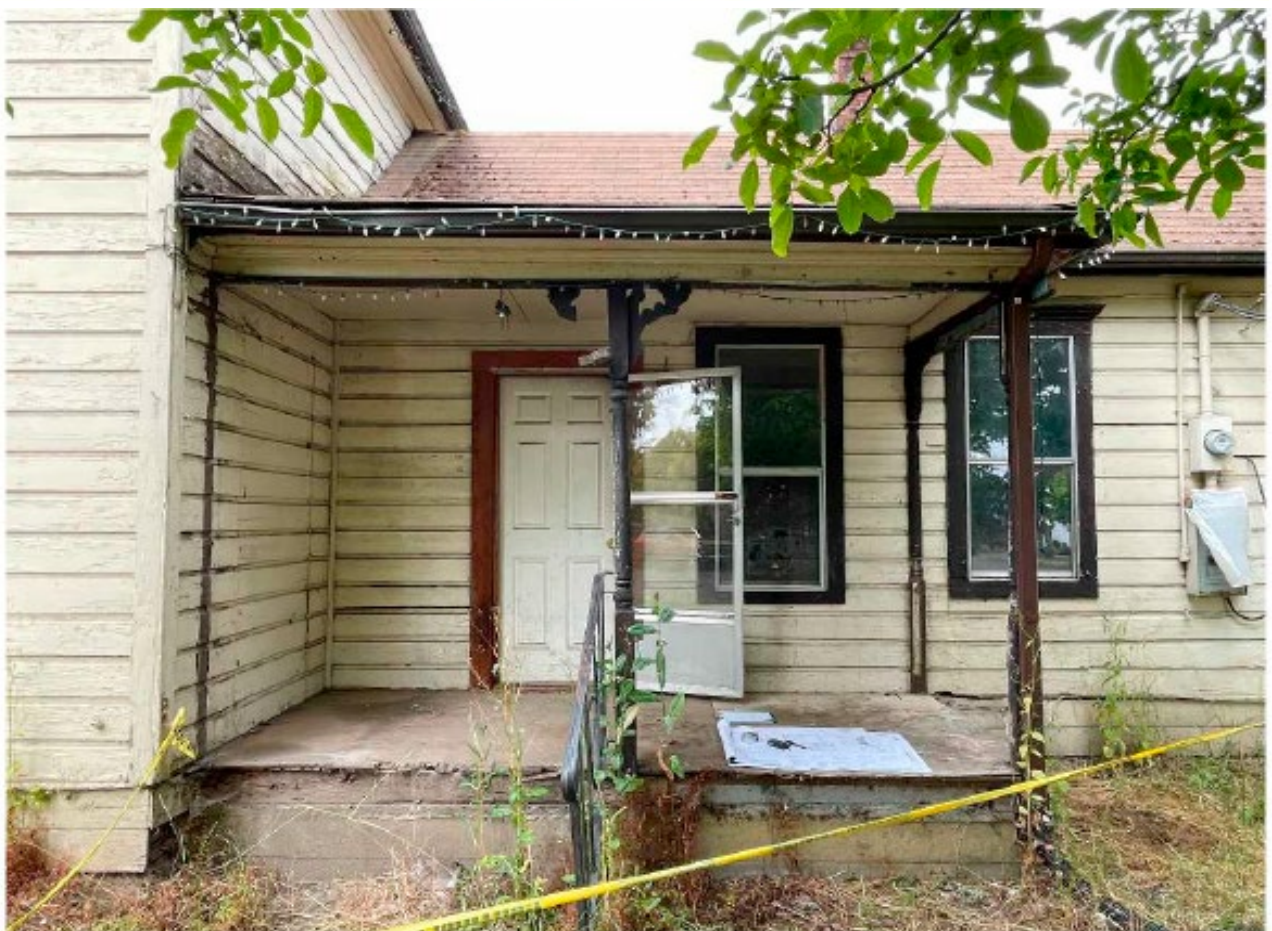
Figure 3: Photos of Current Exterior Conditions

The applicant plans to replace rotted siding with new wooden siding as well as remove the period incorrect aluminum windows, and replace them with period correct wooden windows. The applicant also plans to repair the front porch and its railing with new wood designed to match the historic design of the home. They also plan to repair the rear of the shed roof and add a new dormer there. The electrical meter will also be rerouted to the rear of the home from its current location in the front in order to enhance the historic character of the home.

The applicant plans to replace rotted siding with new wooden siding as well as remove the period incorrect aluminum windows, and replace them with period correct wooden windows. The applicant also plans to repair the front porch and its railing with new wood designed to match the historic design of the home. They also plan to repair the rear of the shed roof and add a new dormer there. The electrical meter will also be rerouted to the rear of the home from its current location in the front in order to enhance the historic character of the home.

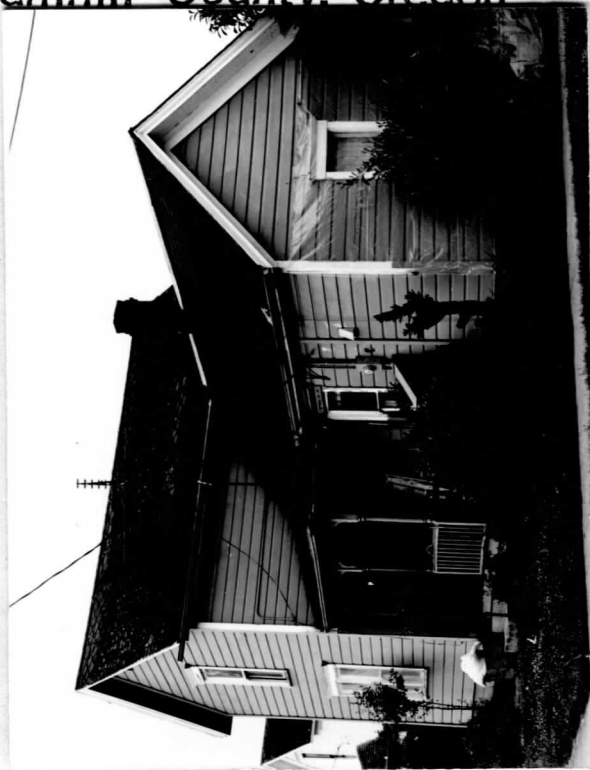
Site No. 21.7 Aerial Map K-9
 Block 29 Lot 4
 Addition Oak Park
 Tax Lot 4421 BB 6900
 Address 935 N Galloway OK
 Common Name -
 Historic Name -
 Present Owner Cecilio and Yolanda Suarez
 Present Use Residence
 Original Use "
 Builder or Architect unknown
 Outbuildings garage (West property line)
 Date of Construction c. 1895

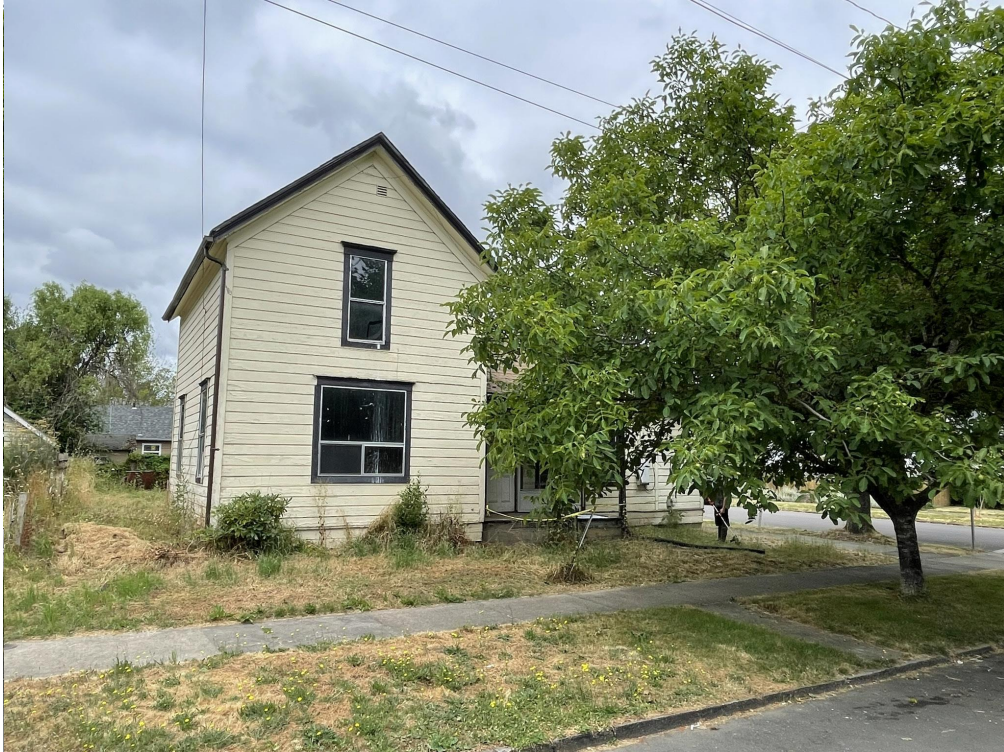
FRONT OF HOUSE FROM NE GALLOWAY

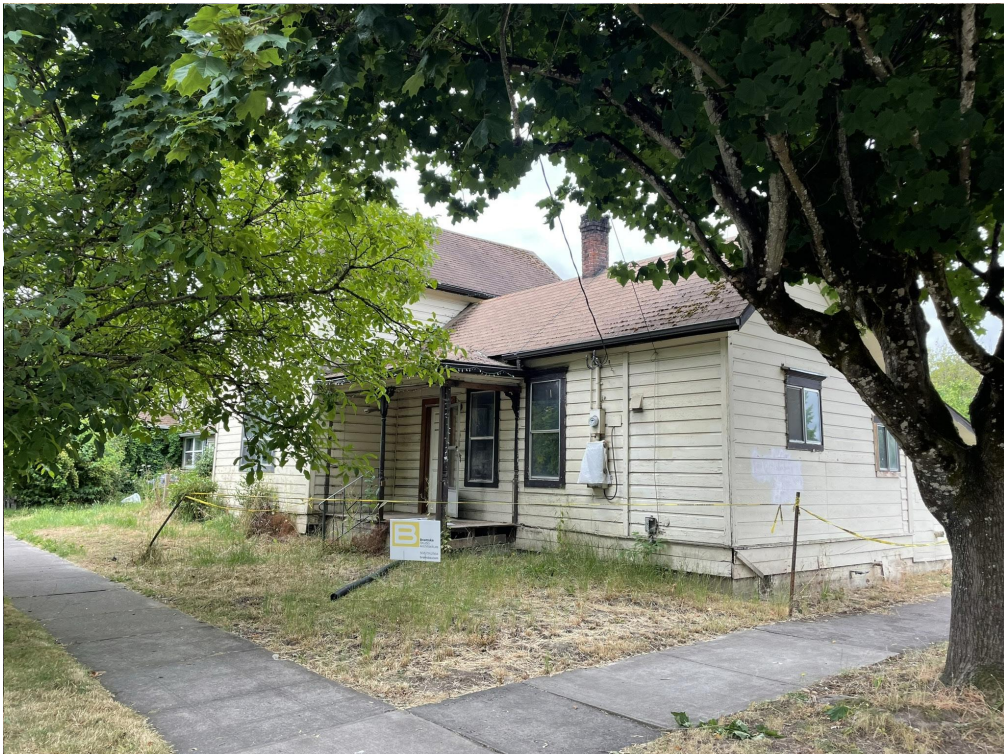
FRONT OF HOUSE FROM NE GALLOWAY & NE 10TH AVENUE

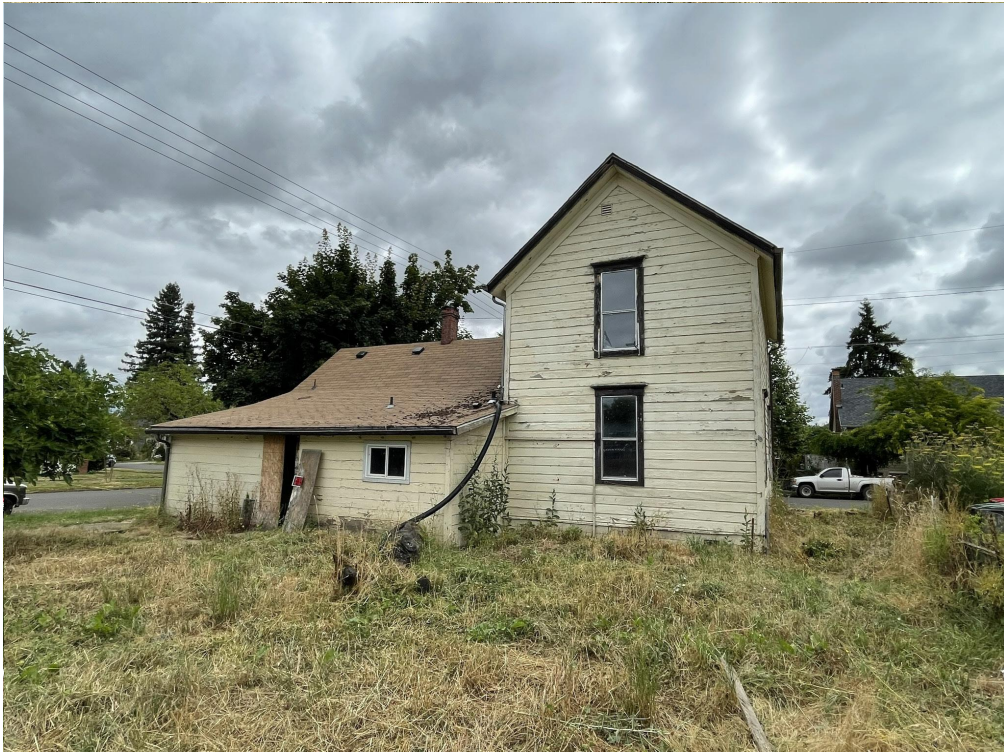
HOUSE AS VIEWED FROM BACKYARD

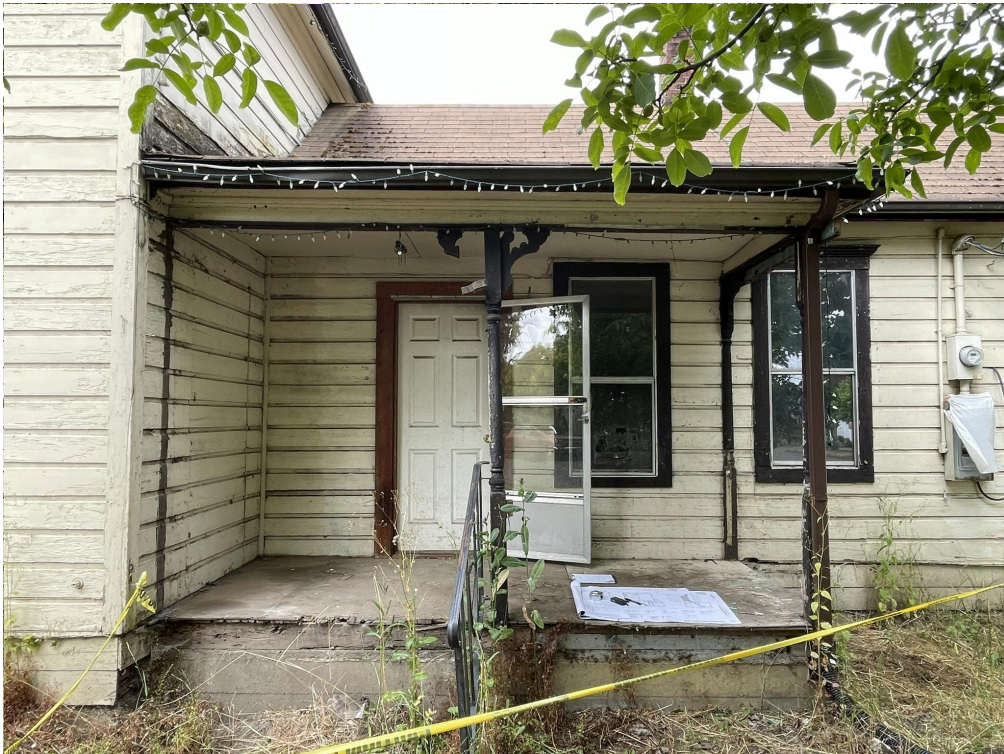
FRONT PORCH

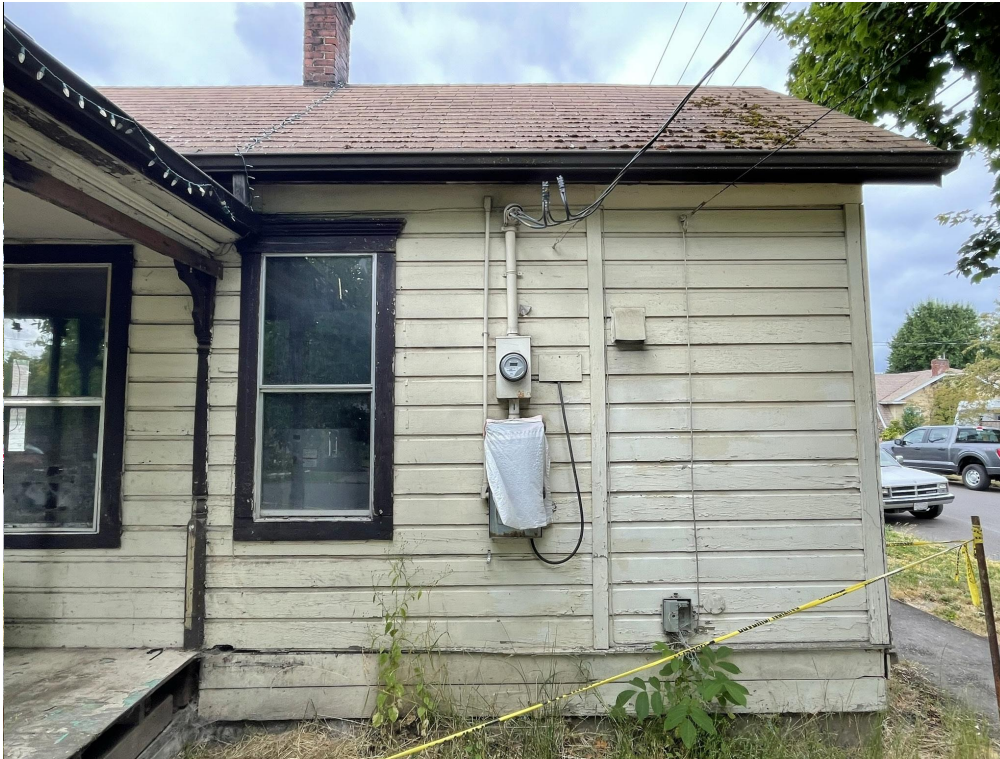
FRONT OF HOUSE SHOWING JOINT AT PREVIOUS ADDITION TO HOUSE

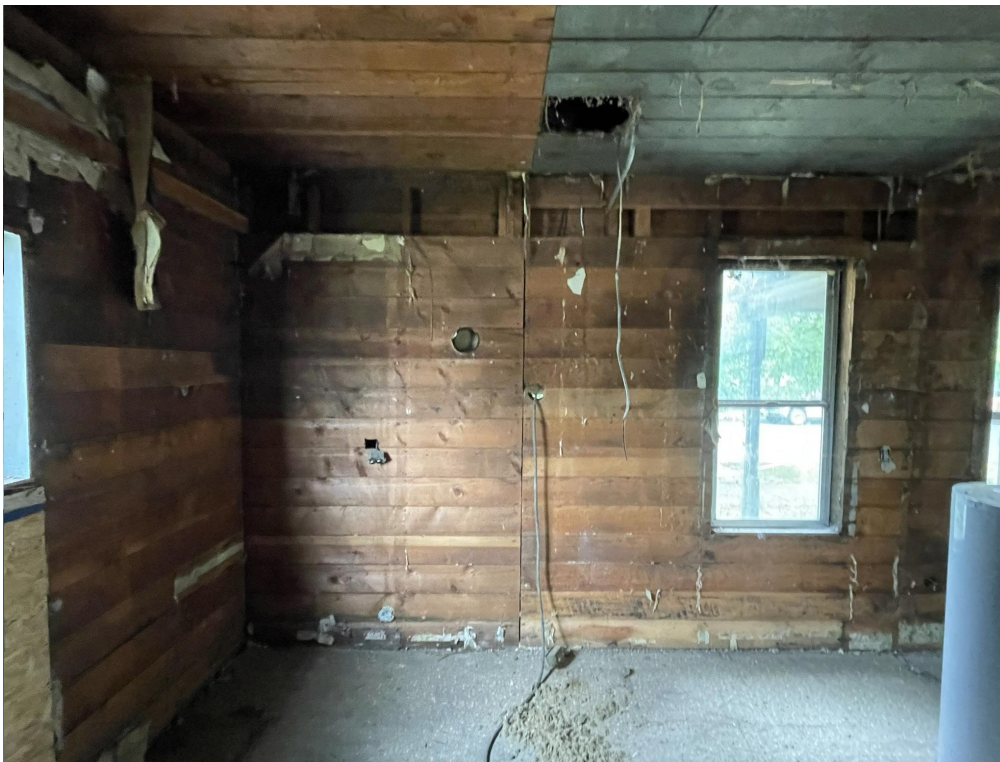
INTERIOR OF LIVING ROOM SHOWING LINE IN FINISHES AT PREVIOUS ADDITION TO HOUSE

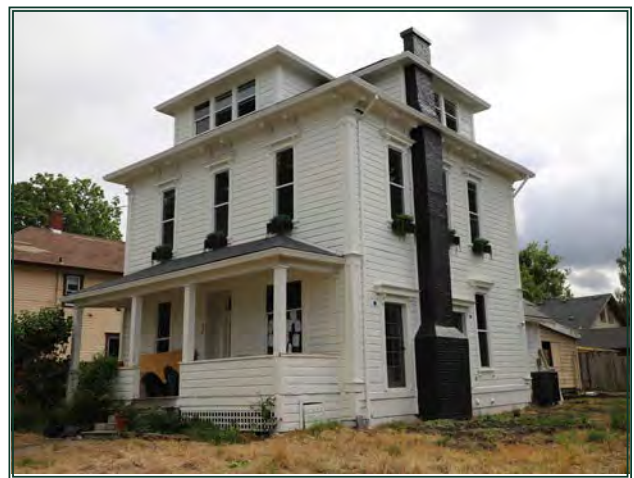
436 SE Baker Street (ca. 1870), Italianate house.

Of the 371 buildings surveyed, one was built during this period. This building, a single-family dwelling at 436 SE Baker Street, was constructed ca. 1870 and exhibits the Italianate style.

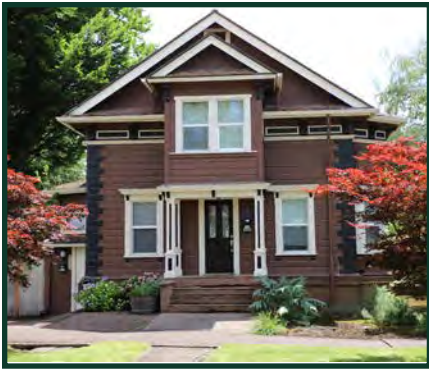
508 SE Washington (1880), Italianate house.

The **Italianate style** was contemporary with Gothic Revival and was also a reaction against classical architecture. It drew from sixteenth century Italian villas, utilizing and simplify their ornamentation. The style was popular in Oregon between the 1870s and 1890s. Residential Italianate examples are marked by decorative detailing around windows and doors, arched windows, often in pairs or threes, and elaborate, bracketed cornices. Italianate buildings may include square towers, cupolas, or lanterns.³

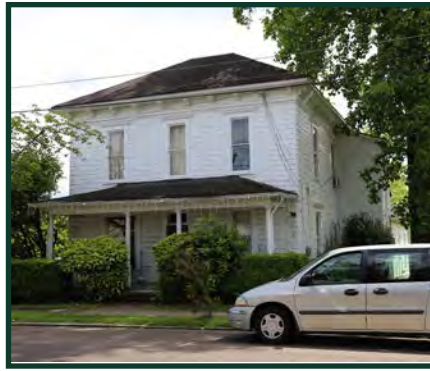
642 SE 1st Street (1885), Italianate house.

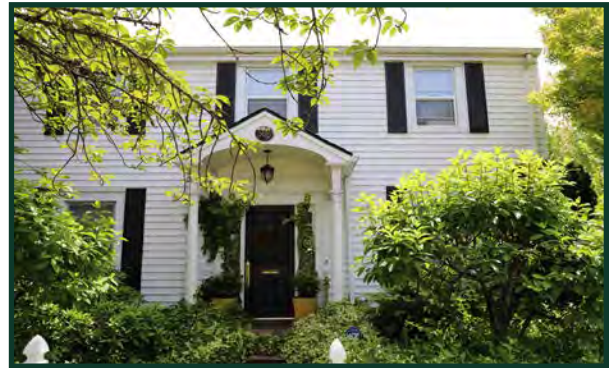
506 SE 1st Street (ca. 1930), a Colonial Revival example.

The **Colonial Revival style** began in the late nineteenth century and continued in popularity through the first few decades of the twentieth century. By 1900 it had become one of the more popular residential styles in the Pacific Northwest and in the Willamette Valley. The Colonial Revival style is distinguished by its use of symmetrical distribution of windows and doors, especially on the principal elevation, and the application of somewhat muted classical elements. These elements include pedimented or segmentally pedimented entry porches and gables, eave returns on gable ends, window and door trim with varying degrees of elaborated moldings, corner boards, and entry doors flanked with sidelights and frequently topped by a transom. Windows tend to be double-hung with multi-light sashes on the upper or both sashes.⁵ Colonial Revival examples within the survey area include 506 SE 1st Street (ca. 1930) and 835 SE Villard Street (ca. 1900).

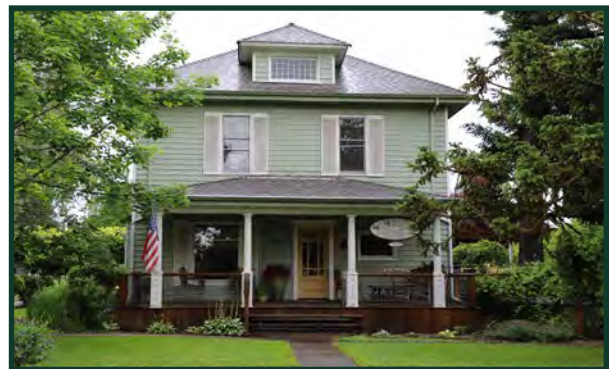
835 SE Villard Street (ca. 1900), a foursquare Colonial Revival example.

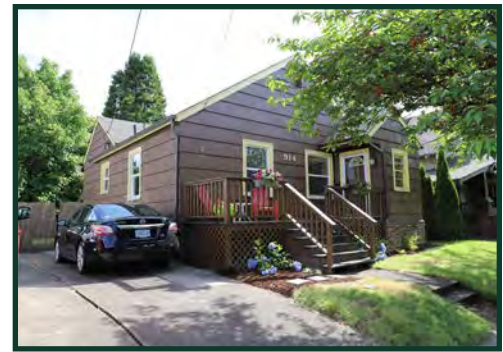
914 SE 1st Street (ca. 1949), a Minimal Traditional example.

Minimal Traditional examples from this period include 914 SE 1st Street (ca. 1949), 327 SE Adams Street (ca. 1949), and 1217 SE Brooks Street (ca. 1949).

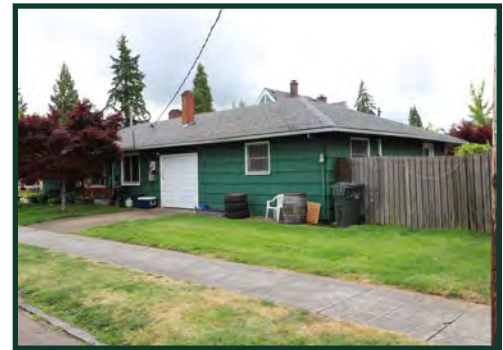
310 SE Lincoln Street (ca. 1955), Ranch example.

Ranch houses became popular in the post-war decades. Ranches from the 1950s resemble Minimal Traditional houses in form but with a very low-pitched, hip roof rather than gables. Ornamentation is minimal, generally restricted to applied features such as veneer siding on the lower portions of the elevations and incorporated planters along principal elevations. During the 1960s, the overall shape of the Ranch style moved away from more compact floor plans toward a sprawling, linear floor plan, the building footprint stretching out to a long, narrow side-gabled massing, often

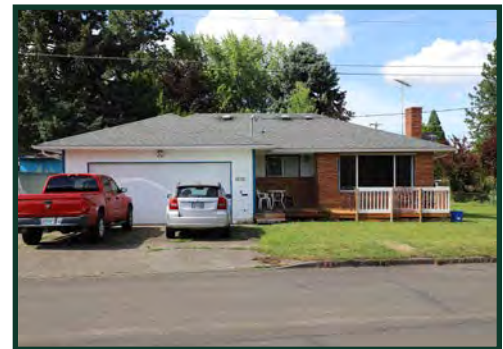
1313 SE Brooks Street (ca. 1956), a Ranch example.

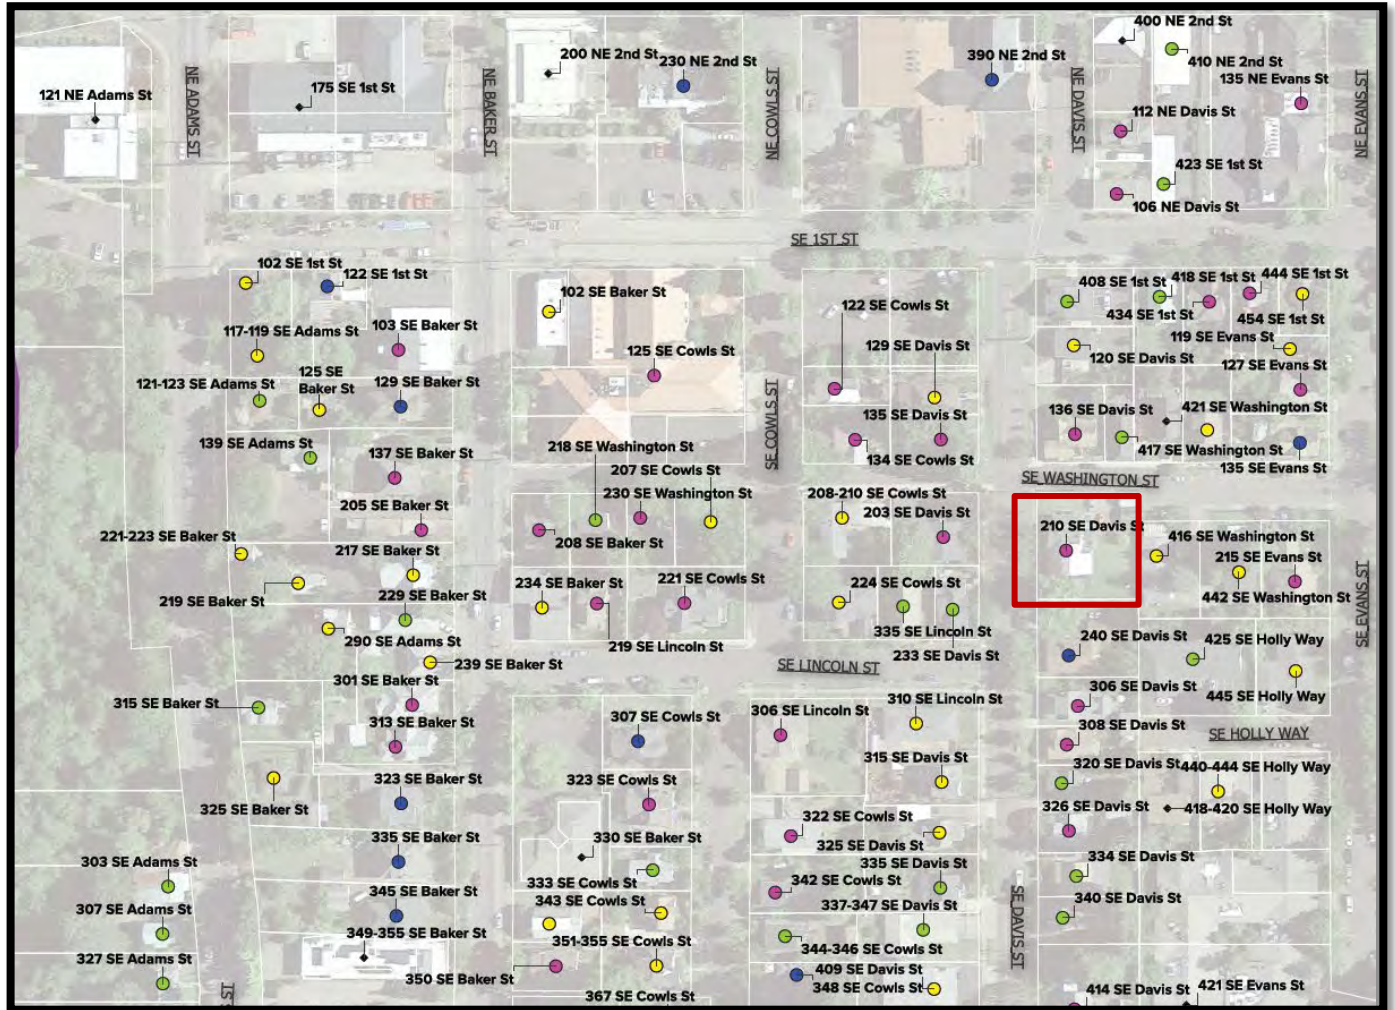
Map indicating McMinnville Historic Resources Inventory classifications for surveyed structures. Page 38, City of McMinnville, Reconnaissance Level Survey, July 2020

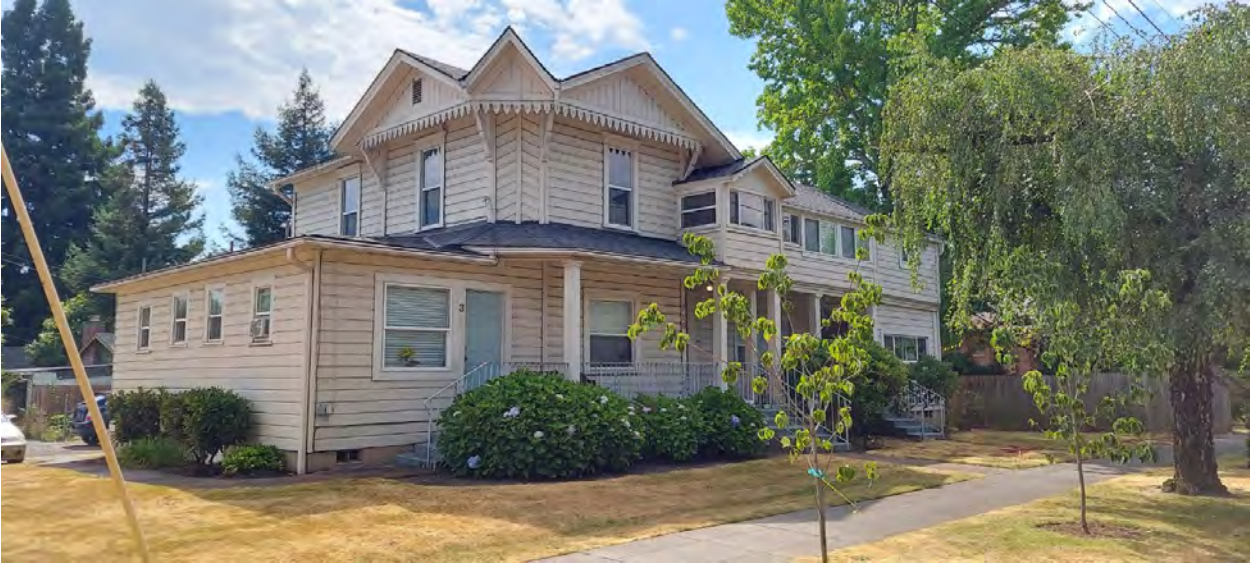
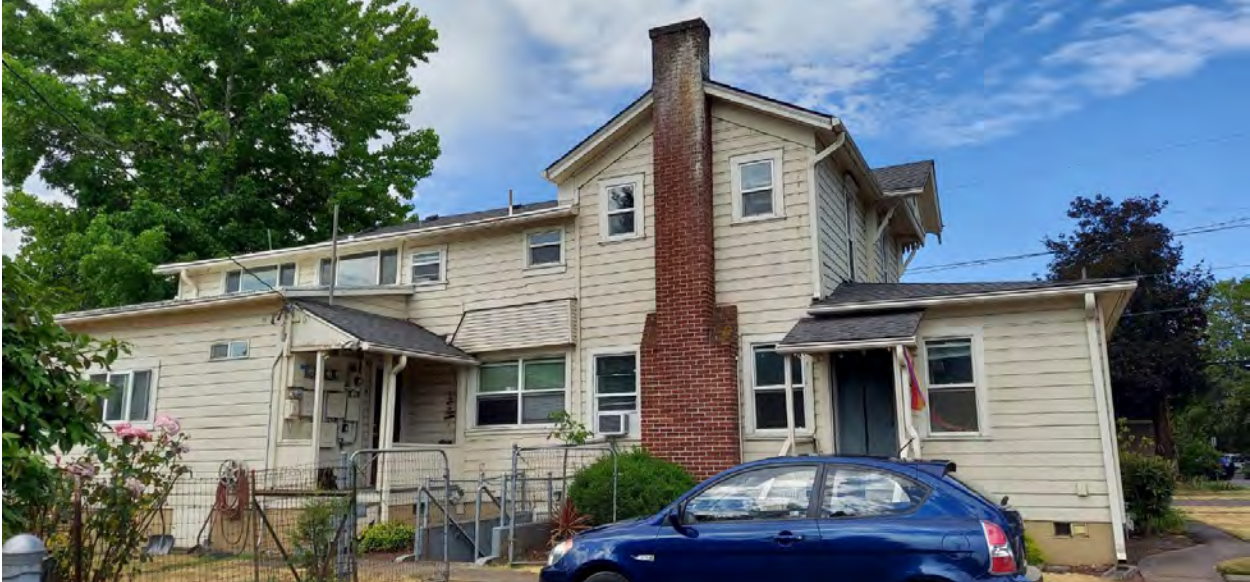
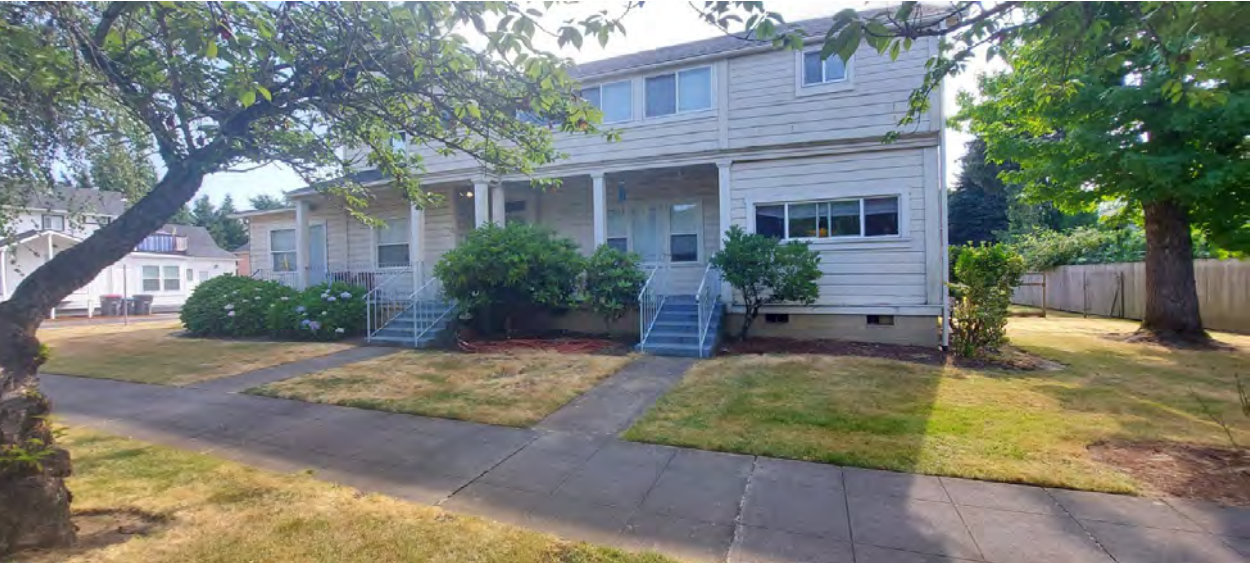
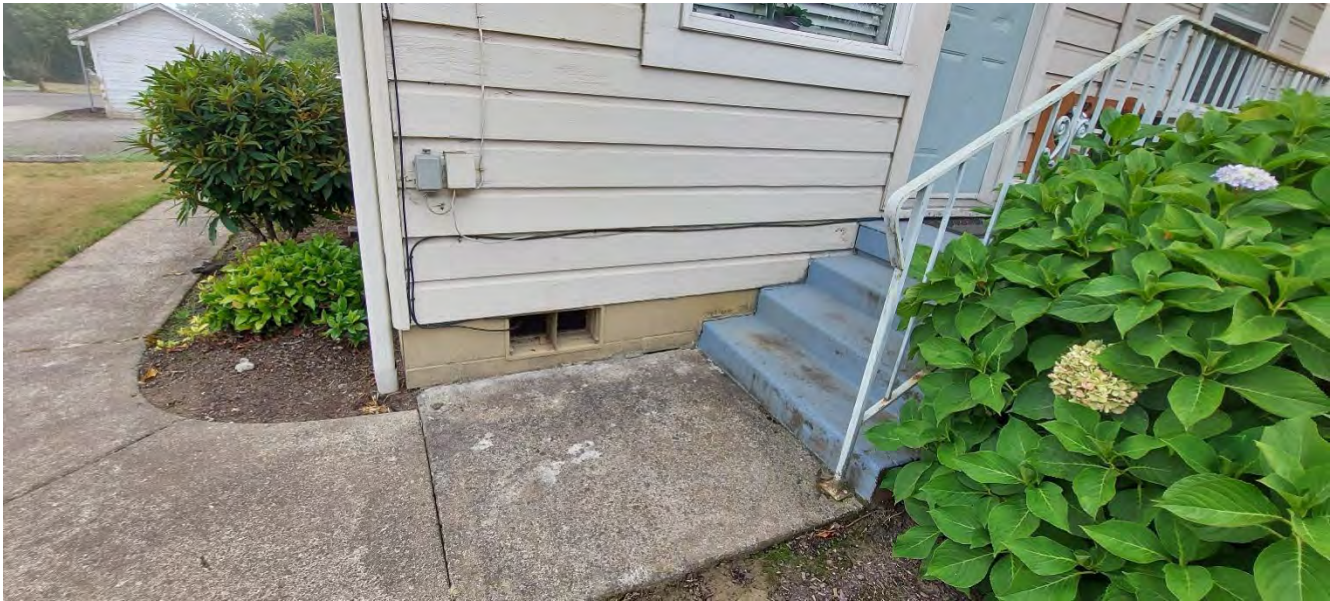
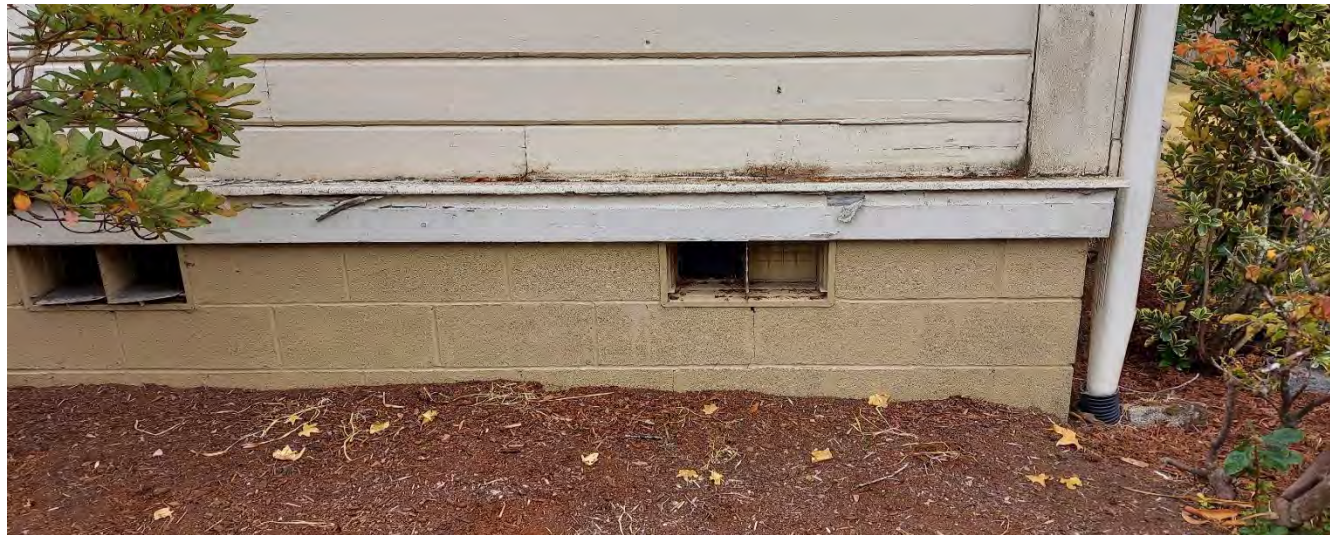
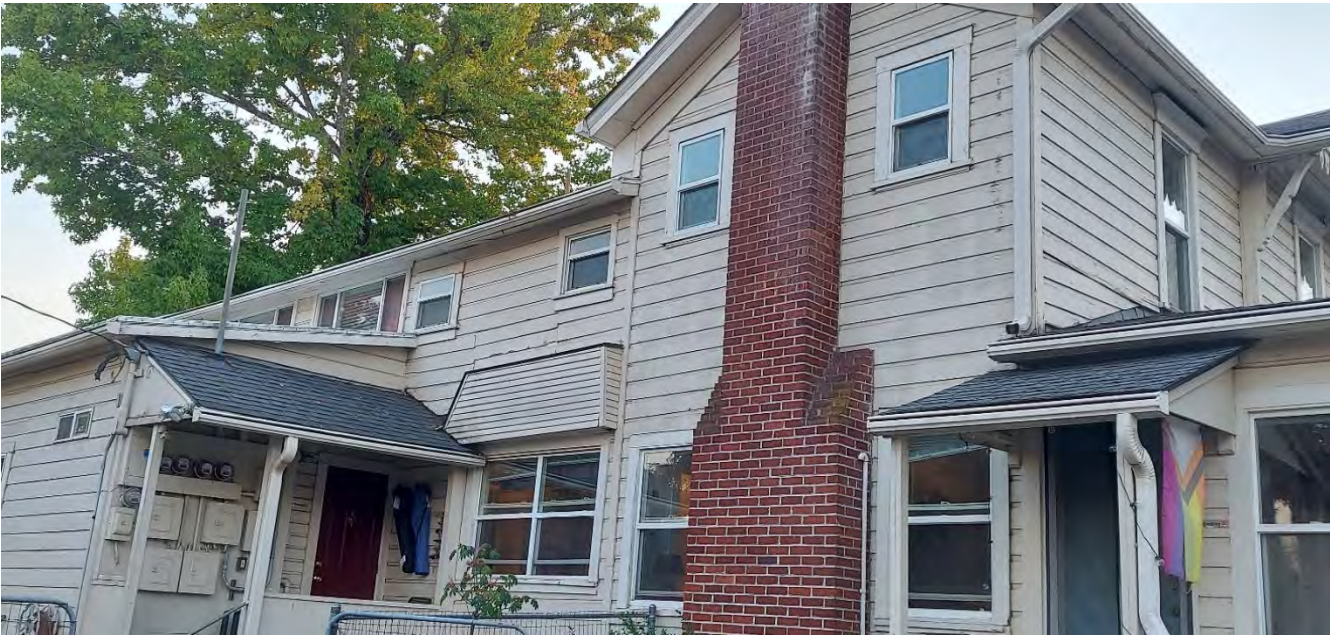
Figure 4: Photos of Current Exterior Conditions

Due to the vinyl windows and some of the additions that have occurred on the property, Northwest Vernacular did not believe that it would be National Register eligible either as an individual property or as a contributing property in a National Register of Historic Places historic district. However, they did feel that it merited remaining listed on the McMinnville Historic Resources Inventory as a significant historic resource due to its representation and association with McMinnville’s second historic period of growth and development and Queen Anne style architecture.

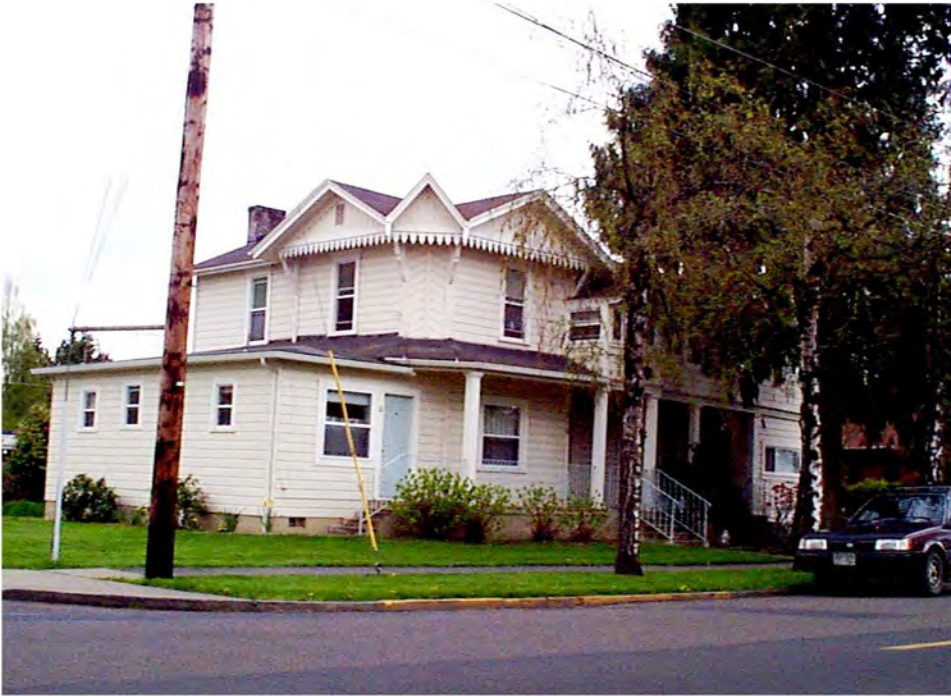
Photo August 2001

The structure has wood frame construction, horizontal medium width siding, composition roof and concrete foundation. Decorative sawn wood work is found under the multiple gables.
