**Historic Resources Survey
City of McMinnville
Yamhill County, Oregon**

300 NE 3rd St.

Hodson Building

Historic Resource No. A450

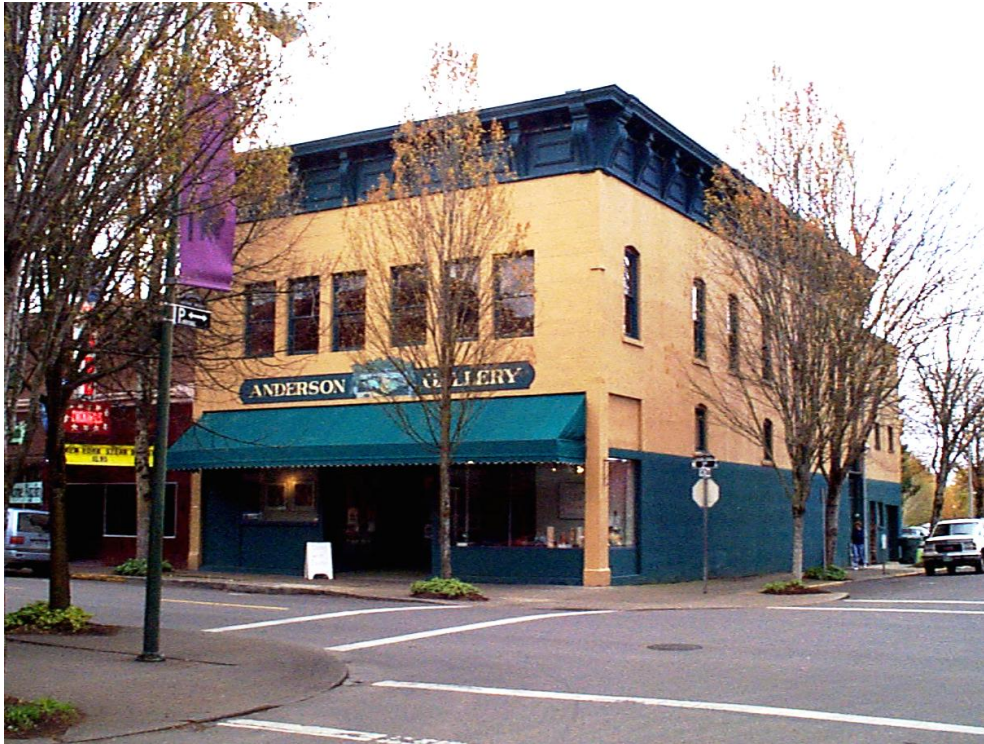
Photo April 2001

A rectangular, Italianate, two-storied stuccoed brick structure, the Sears building faces north on the corner of Third and Cows. A shorter section on the rear of the building appears to be an addition. The building has a basement. There are two sets of three inset double-hung one-over-one windows with no ornament at the second floor level on the façade. The east façade has irregular fenestration; the second story windows are arched, double-hung sash, and those on the ground floor are single-paned. All have simple, splayed sills. Windows on the rear addition are four-lighted, inset squares. The projecting cornice conceals the roofline and is supported by large scrolled brackets and smaller modillions. There is a paneled frieze below the cornice. The original façade at the first floor level has been replaced by large store windows and setback entry. The south elevation is sheathed in corrugated sheet metal; unpainted brick shows on the exposed portion of the east side.

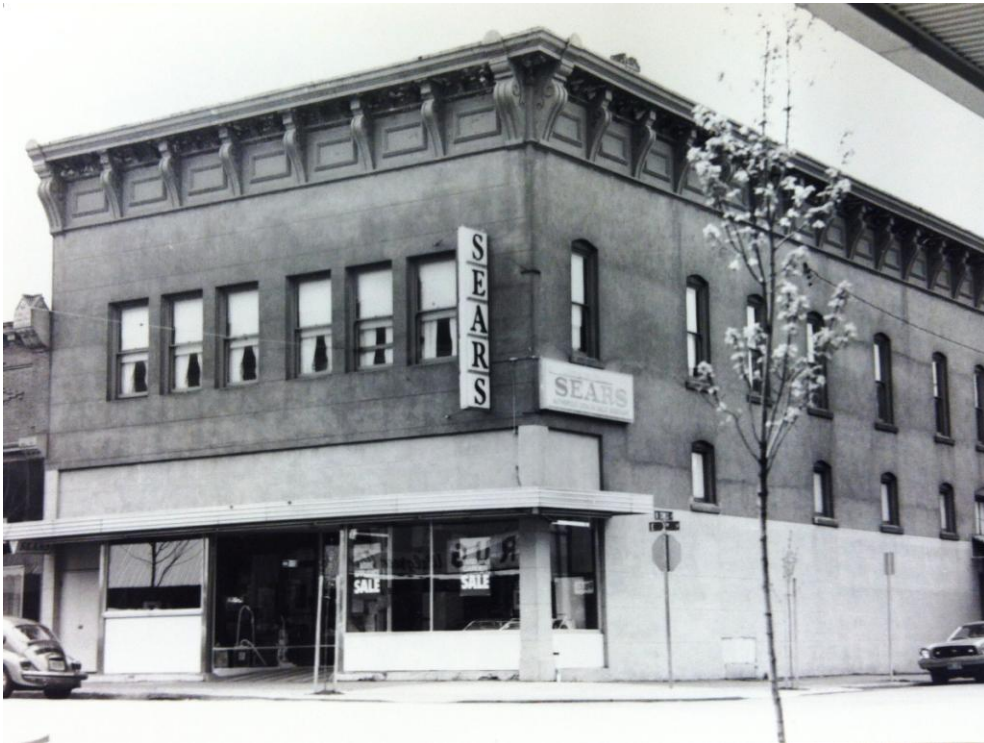
Original 1983 Survey Photo

Fair

In need of paint.
