Historic Resources Survey City of McMinnville Yamhill County, Oregon

Historic Resource Survey City of McMinnville Yamhill County, Oregon

Historic Resource No. B1129 (1130 & 1131) Demolished 1988

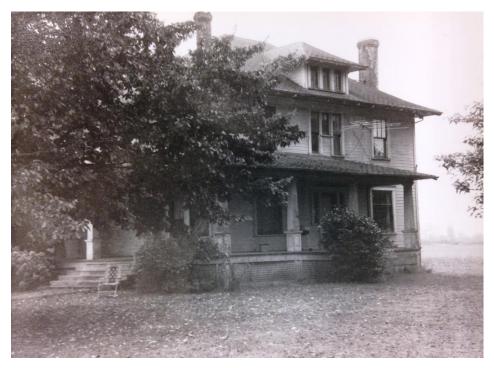
B1129

This is an imposing two and one-half story craftsman bungalow style house, which in its day must have been the wonder of the countryside east of town.

The roof is a medium high hip with hipped three-light dormer facing front. The roof is flattish hip and flattish hip roof over the very broad porch which runs along two sides of the house. It has wide eaves with exposed rafters. The porch roof is supported by large batter wooden pillars on three foot high pedestals and bases, and recessed panels, and resemble stone construction. Siding is narrow beveled with plain corner trim. There is an interesting variety of windows, typically 3/1 double hung. Windows have architrave molding. The house has a central chimney with corbelled cap and another chimney on the side, also with corbelled cap.

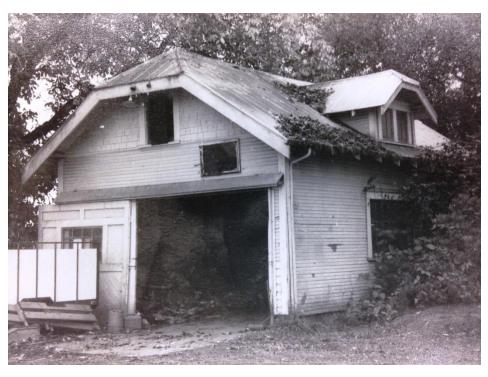
B1130

The garage is a one and one-half story building with jerkinhead roof. It has a dormer, also with jerkinhead roof. The garage has narrow beveled siding, windows under the gable, and in the dormer have architrave molding. The area under the gable, above wall height, is shingled.

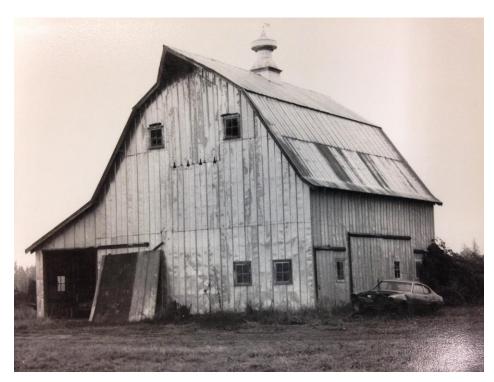
B1131
Original 1983 Survey Photo

The barn is a replacement of one which burned some years and is of corrugated metal construction. It has gambrel roof with bell cast edges and forward prow. A decorative metal vent sits on ridge. Occupant of the house says the original barn was a dairy barn.
