Historic Resources Survey City of McMinnville Yamhill County, Oregon

835 SW Ashwood (Kenneth & Dorothy Fender)

Historic Resource No. B115

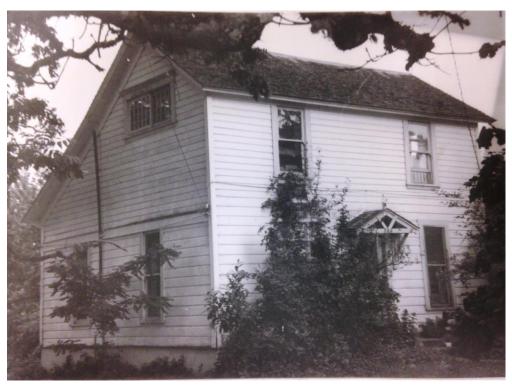
The house has a high gable with boxed cornices. There is novelty siding on the ground floor and wider weatherboards on the second floor. Windows have plain tops and sides, but have lugsills.

There used to be a porch across the front of the building, but this has been replaced by a small stoop with a gable (eyebrow) roof.

Windows are sash 1/1, but at the south end of the second floor there are two windows which have 20 pane sash.

Original 1983 Survey Photo
