**Historic Resources Survey  
City of McMinnville  
Yamhill County, Oregon**

1117 NE Cowls Street

**Historic Resource No. B240**

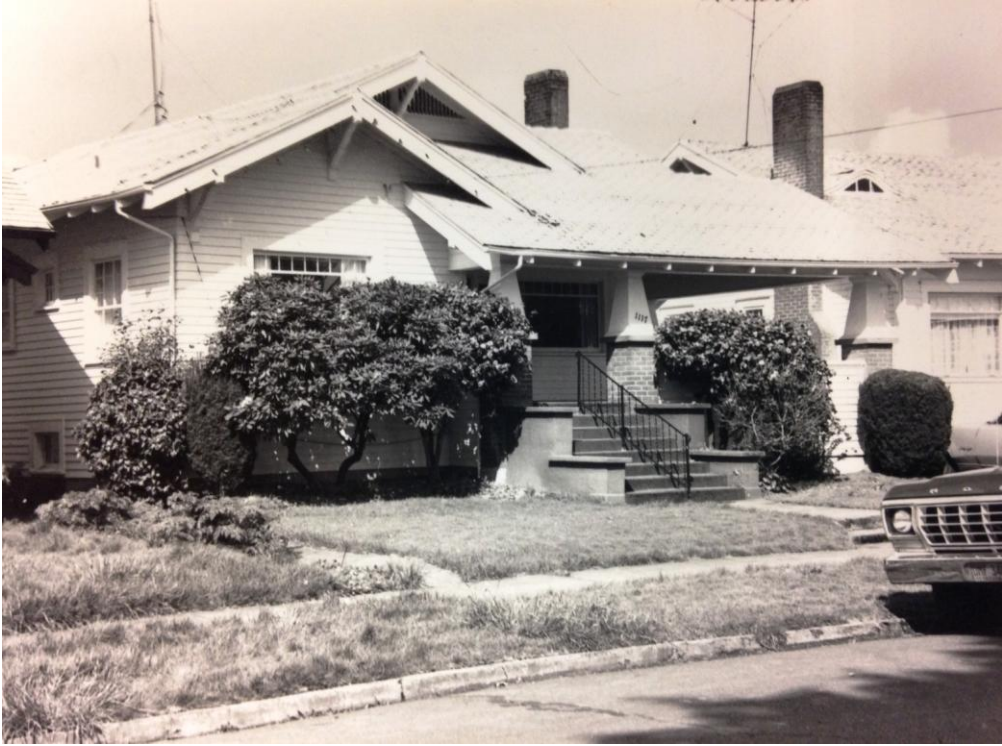
This is a one-story craftsman bungalow of generous size. It has high gables, exposed rafters, ornate roof brackets and plain vergeboards. It has weatherboard siding.

There is a wide porch on the north 2/3 of the front which extends halfway around along the north side. The roof is supported by massive battered piers, framed, which are perhaps twice as wide at the bottom as at the top. They rest on brick pedestals about two feet square which have a concrete cap. There are wide concrete balustrades along each side of the steps leading to the porch.

Under the gable at the peak of the house, in front, is a lattice-like element (perhaps an attic vent). There is an outside chimney at the north side.

The front door has five lights, and two sidelights consisting of five lights each. Other windows have 10/1 sash, and some fixed windows have nine lights. Two large front windows have a very large lower light, above which is a row of nine lights. Windows and doors have plain surround.

On the north side, a French door opens onto the porch.

Original 1983 Survey Photo
