**Historic Resources Survey
City of McMinnville
Yamhill County, Oregon**

1595 SW Cypress Ln.

Old Peavy Place

Historic Resource No. B24 (B23 Barn)

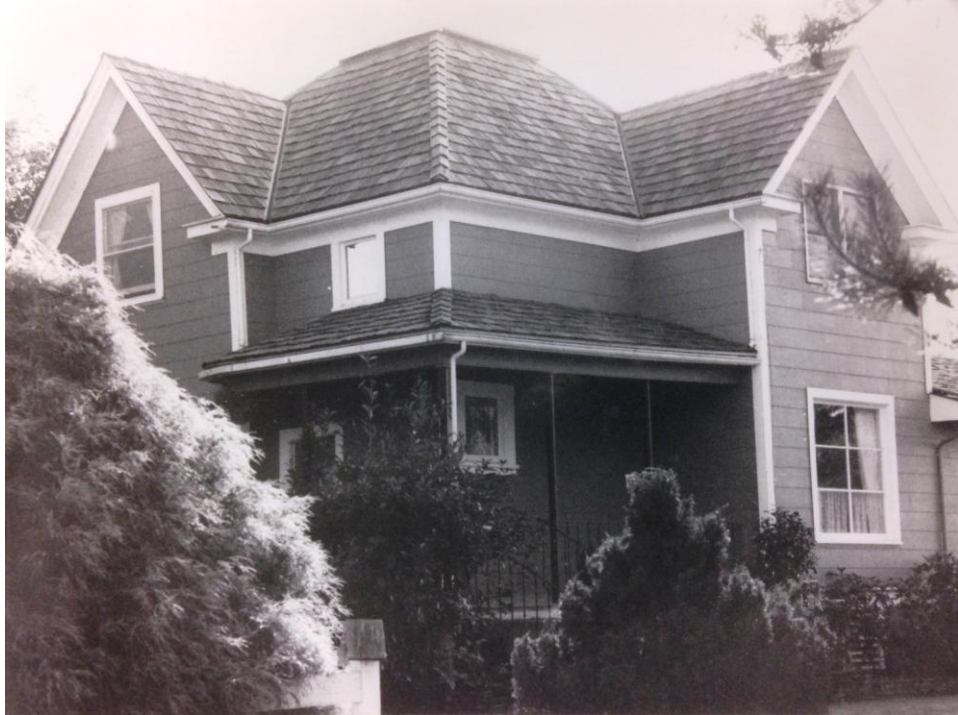
Original 1983 Survey Photo

This is a big, squarish two-story house. It has high gables with returns, boxed cornices frieze board, and moulding. A square two-story tower has a bellcast hip roof which curves gracefully up to a point.

The roof ridge of another section is truncated as if for a skylight. Many windows appear new. They have plain surrounds. At the rear of the house are a couple of one-story sections with low hip roofs. These sections look like additions. The front entrance is off a curved porch with an iron rail and iron roof posts. The front door has a plain surround and three panels. The house has asbestos siding with cornerboards and frieze. There is an outside chimney on the end of the house.

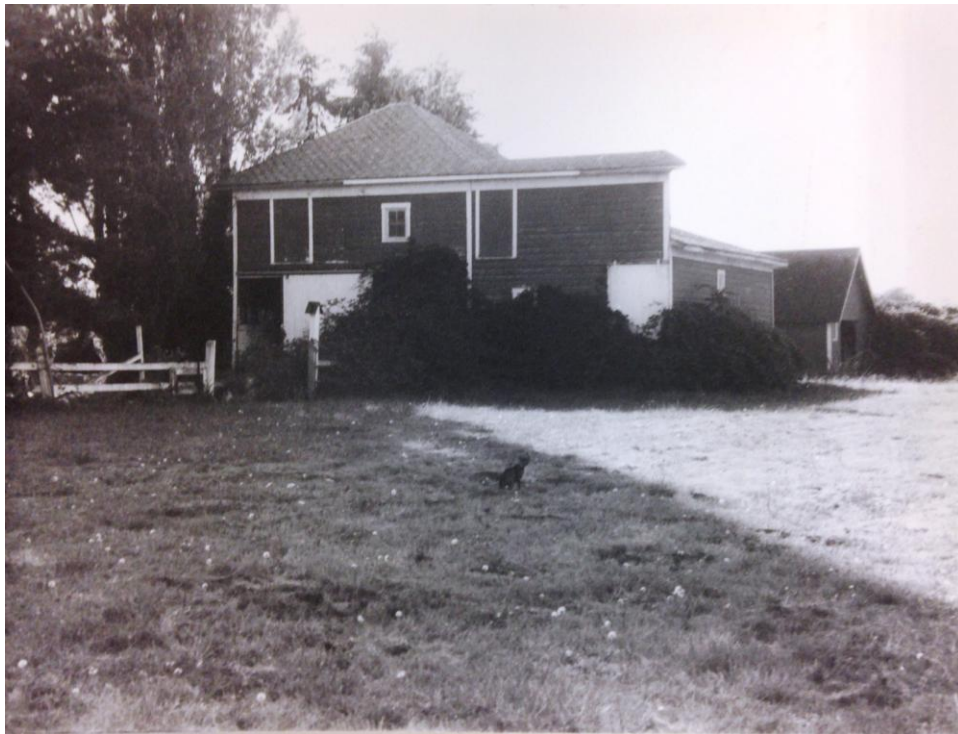
Barn: The barn has a loft with fixed 4-pane windows. The ground level has fixed two and six pane windows. Part of the barn has a hip roof which comes to a point. However, the back and one side have a shed roof. The shed roof on the side is concealed in the front by a boom-town roof which makes the front of the barn appear to have a loft all across the front. The barn has novelty siding. The roof has boxed cornices and a very wide frieze board.
