## Historic Resources Survey City of McMinnville Yamhill County, Oregon

## **Historic Resource No. B376**

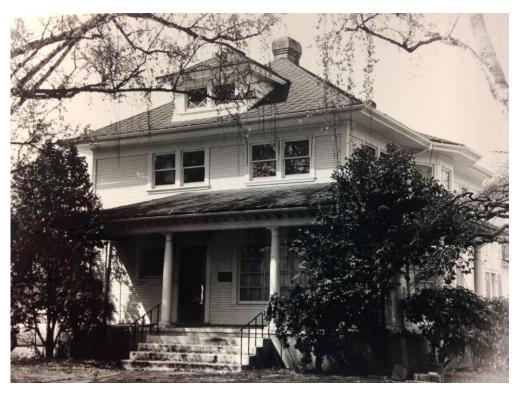
Structure is rectangular in shape with two full stories and one story extension in rear. Am doubtful structure has ever been moved (faces east and sets squarely on corner lot) however there is evidence of an old concrete double track driveway leading to side of home form 7<sup>th</sup> Street. Assessor office records indicate home was built in 1905.

Styling of this structure is basically a rectangular "square box' with hip roof, simple round Tuscan columns on a full front porch. Roof has bracketing all around.

Home is of wood frame construction with plain bevel siding, vertical corner boards and an asphalt roof over full concrete foundation with a basement.

A front facing, hip roof dormer has two interesting windows with a diamond design in center, formed with narrow wood strips and strips radiating from diamond sides to each corner of window. Dormer is enhanced with fish scale shingles.

Front façade is asymmetrical with small leaded Queen Anne window (probably over inner stairway) at one side of front door and large window with twelve lights on other side. Doubt if large window is original.

Home as protruding bays on each side—and irregular fenestration rectangular bay on south and angle, with regular fenestration on north.

North side door may be replacement along with newer side light added also. The house was built by a Miller who also did sidewalks. His grandson, Dr. Malcomb Marquis lives in Portland.

Original 1983 Survey Photo
