**Historic Resources Survey
City of McMinnville
Yamhill County, Oregon**

219 SE Lincoln Street

Julia Gault House

Historic Resource No. B430

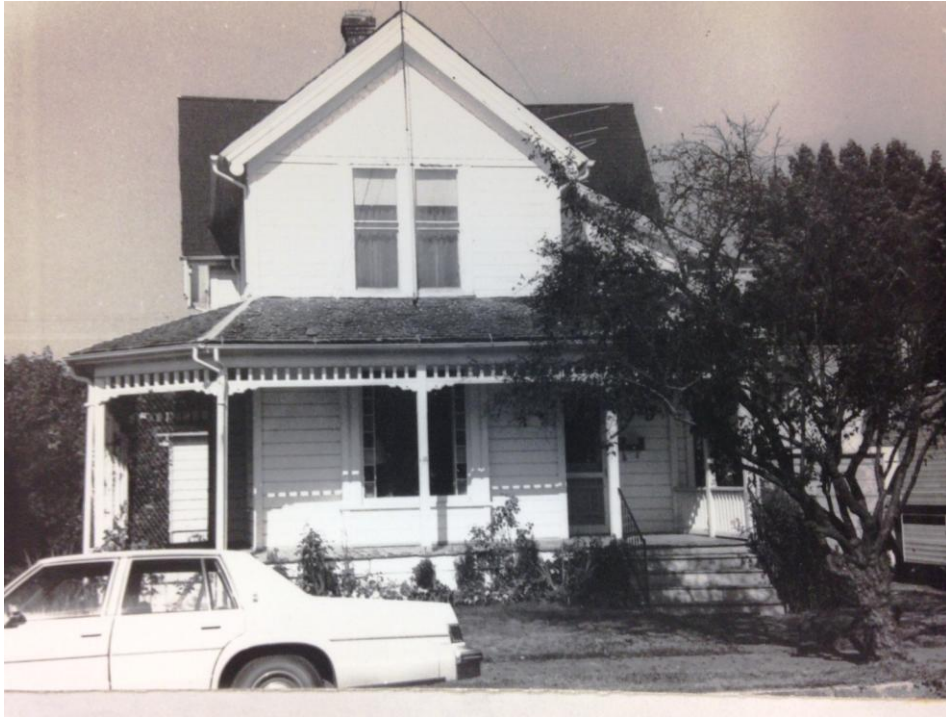
This two-story gabled rural vernacular structure is built on a Latin cross plan with an encircling porch and other detailing showing influence from Queen Anne eclecticism. The siding is "drop" siding except for the upper gables above the windows which are shingled in courses of diamond and imbricated patterns. The central chimney has a corbelled cap. The shed porch roof forms a pediment with fan detail over the porch steps. The detailed porch frieze includes small scroll brackets.

The eaves are boxed with vergeboards, ends rounded as if knobs. The porch railing of simple square section spindle is missing except for the east side sections. Windows are predominately double hung 1/1 with a large fixed sash window on the first story street façade. This window as well as the paneled door windows have single stained (colored) glass side lights. Door and window frames have a single cornice cap except where belt boards form the upper frame member.

Original 1983 Survey Photo
