Historic Resources Survey City of McMinnville Yamhill County, Oregon

Historic Resource Survey City of McMinnville Yamhill County, Oregon

Historic Resource No. B50

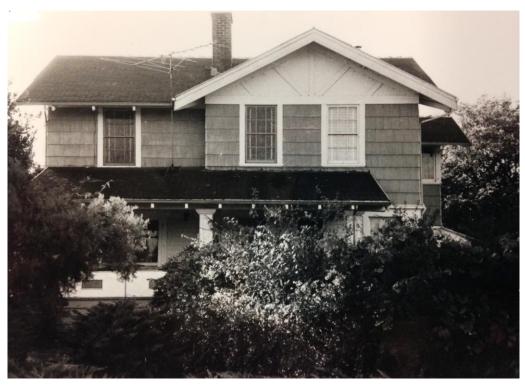
This two-story box has craftsman bungalow detailing. It has a medium gable roof with an east facing dormer (the house is oriented north/south). The south facing entry porch is on the west side of the façade and has a gable pediment roof with exposed beams and rafters and medium wide vergeboards, resting on square columns with recessed bevels. The porch has open railing. Stair rails are wrought iron. Window sash are typically 6/6 double hung. There is a three-window bay with shed roof to the east of the entry porch. The upstairs windows have shutters. Siding on the first floor is clapboard; above are wide cedar shingles. A belt course separates them. The gables are stucco and half-timber. There is a recent addition of narrow brick facing on the lower west side. There is a wide shed roof porch on the east side with double doors. Its detailing is similar to the south porch. On the rear of the north side is a windowed second story sleeping porch with unusually wide overhanging eaves.

The massing of this house is imposing. The cross gables are wide and deep and rise a full two and one-half stories. The chimney is just off center.

Original 1983 Survey Photo
