**Historic Resources Survey  
City of McMinnville  
Yamhill County, Oregon**

1200 NW Michelbook Lane

**Historic Resource No. B56  
(moved to 450 SW Linfield Ave. – 1991)**

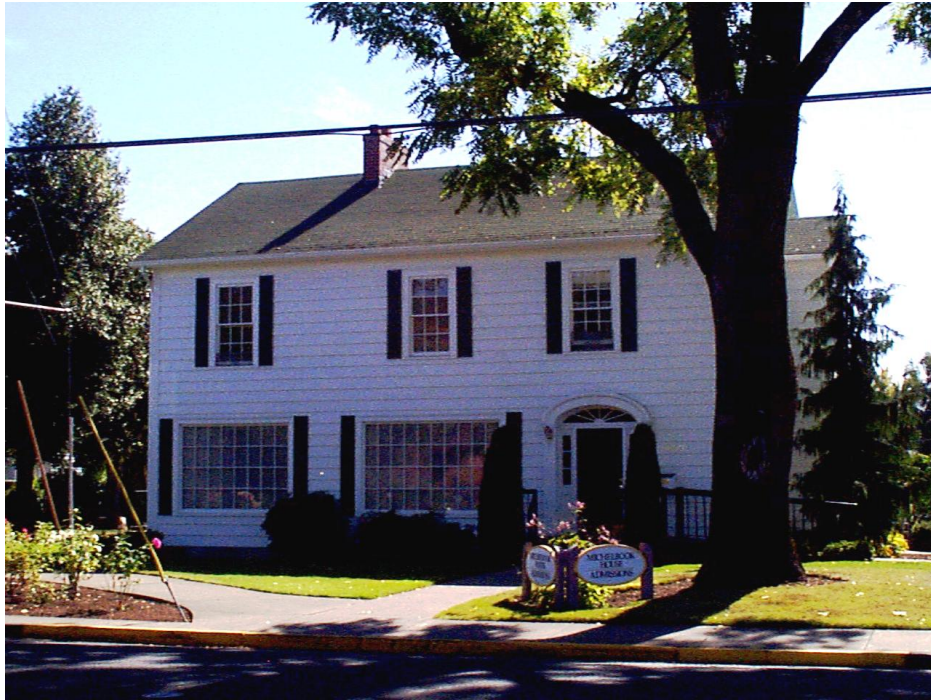
Photo October 2001

Spectacular landscaping dominates the Colonial style two-story structure which has a central block with one wing. The house is situated on an oversized lot facing east which includes numerous massive evergreen, oak and walnut trees.

The low gabled roof has corniced box plain returns on the north and south. The asymmetrically placed frontispiece northeast entrance has an arched opening with semi-elliptical fanlight and three-light top half sidelights framing a six-panel single door with hood mould. The brick walk step porch is semi circular with a wrought iron railing. There is a 15-light central entry on the south off a large brick porch with wrought iron railing.

The north side has a two-story bay off the central block with gabled roof and corniced boxed return. There is also an attached carport with shed roof. There is a combination of window types as follows: first floor east—40-light and 32-light windows; second floor—6/12/6 three-panel (side panels inward opening casement), also two 6/6 double hung sash windows; second floor west—21-light windows; north side—a gothic sash window with hood mould placed between stories and 6/6 double hung sash windows.

The house is in an excellent state of preservation. The exterior siding is weatherboarding; the foundation is concrete; and the roof is composition shingle. The interior brick chimney has three pots with spine moulding.
