**Historic Resources Survey  
City of McMinnville  
Yamhill County, Oregon**

The Maulding House

**Historic Resource No. B598  
Demolished 2002**

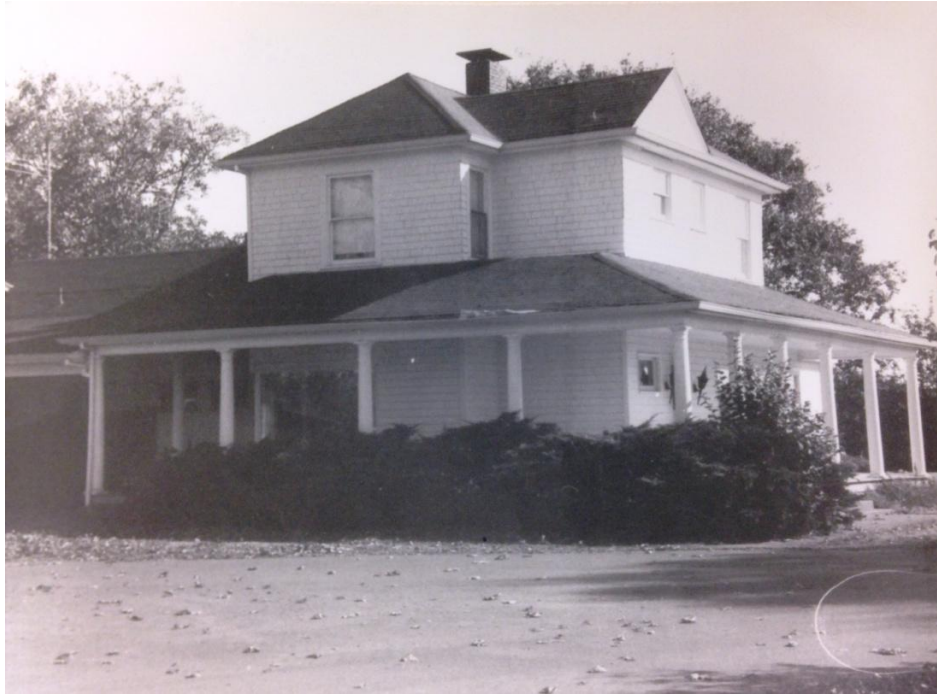
The approach to this impressive country residence is long and direct, veering left only as the house is reached. A classical colonnade wraps around the almost square two story central mass. The low pitched roof combines hip and gable features. The porch roof is hipped; siding is shingle above, possibly aluminum below. A long, nondescript one story addition extends to the rear of the house. Windows are typically 1/1 double hung, except on the first floor where large picture windows have been installed. There are several permanent mobile home units in the yard, detracting from the elegance of this grand manor.

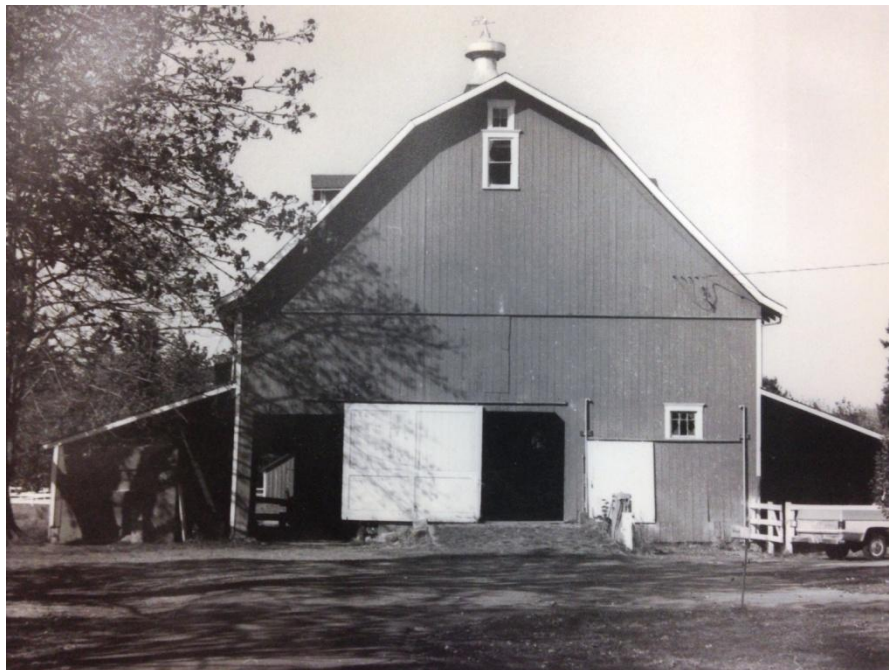
**Historic Resource No. B597  
Relocated to 9101 NW Gass Lane, Carlton - 1999**

The barn was built in 1912 by contractor Allie Arthur and bricklayer Chegwyn as a horse barn. Its roof is a tall gambrel with steep sloping outer flanges ending in slight bell-cast, and short, shallow peak slopes. There are two bell-cast gable dormers on either slope. On the ridge are two conical sheet metal vents topped with weather vanes cut in the silhouette of a dairy cow. Siding is vertical bevel tongue and groove. Symmetrical shed roofed appurtenances have board and batten siding, inward awning windows with unique 3/3 glazing. These windows are in regular spaced groups of two and three. All have cornice mouldings. A white-washed stile fence behind frames a stick pen. Horses are still boarded in the barn, which has five stalls and a loafing shed. There is also a small brick well house with bell-cast gable roof just fifteen yards east of the barn.
