**Historic Resources Survey  
City of McMinnville  
Yamhill County, Oregon**

904 NE Galloway Street

**Historic Resource No. B769**

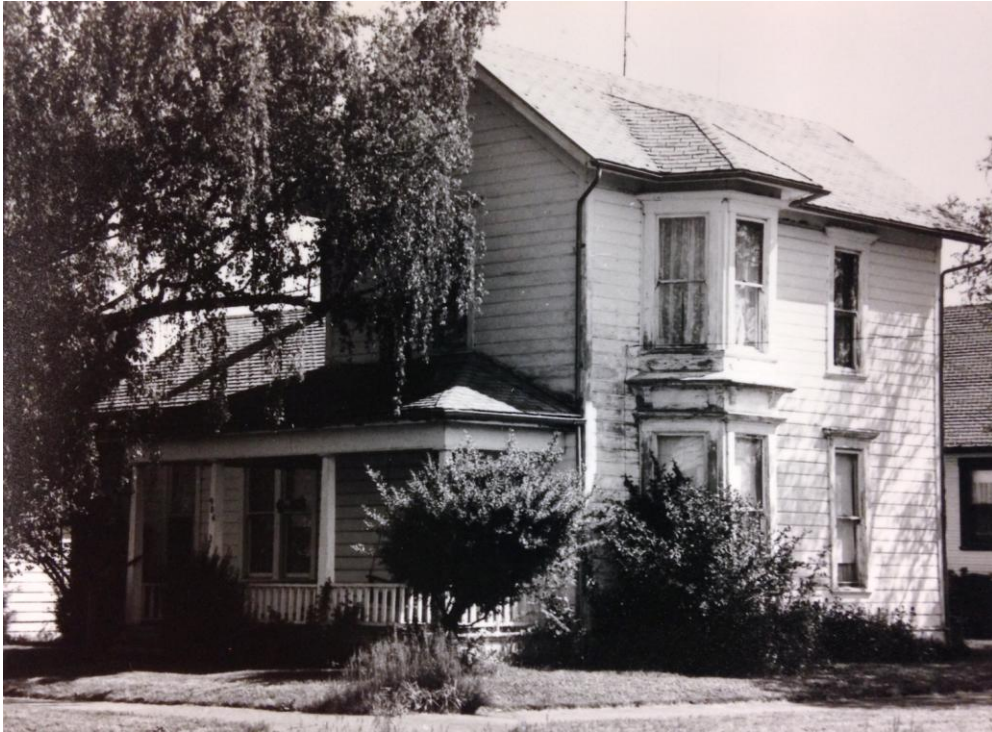
Original 1983 Survey Photo

Good/Fair

Small cracks in walls, chimneys; In need of paint; Poor or no foundation.

This corner lot two-story gable-roofed rural vernacular sits on a corner lot and has immense old trees all round. Italianate influence shows in the two-story bay window which projects from the south elevation. A one-story ell with a lean-to attached forms a T to the north. A later porch with plain square columns and simple balustrade is attached to the west elevation, has a hip roof and covers the entry which opens into the ell. Siding is V-grooved horizontal, corner boards, breeze boards, and rake boards are plain as are the eaves. The foundation is brick.

Fenestration is not regular, but all windows are one-over-one double hung sash with cornice moulding. The bay, the home's only ornament, has a hip roof within the main roof, three separate cornice lines, consoles above the first floor windows, and inset molded panels above the water table.
