**Historic Resources Survey
City of McMinnville
Yamhill County, Oregon**

815 NW Yamhill St.

B84

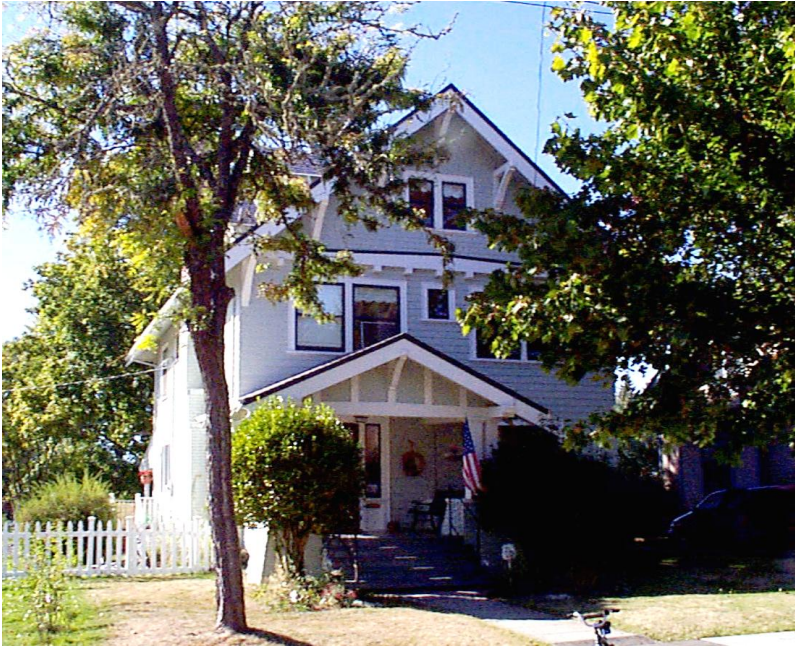
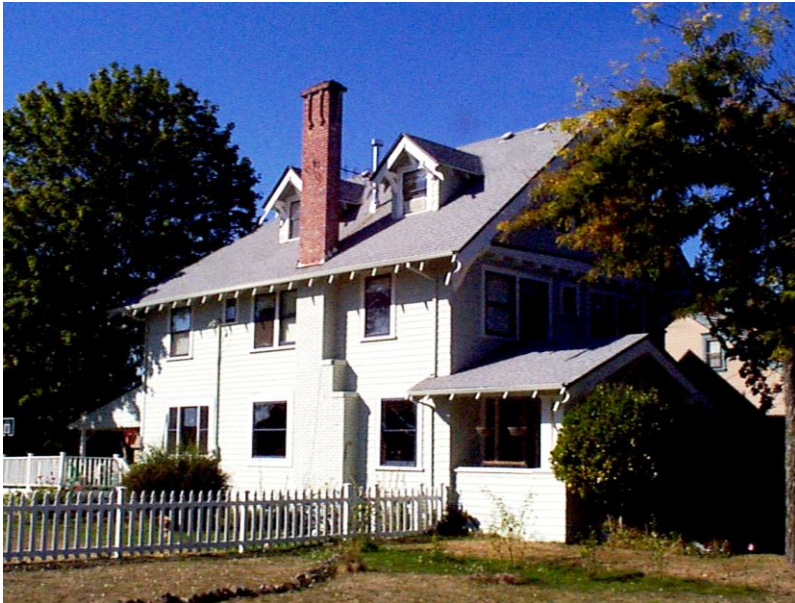
Photos October 2001

This is an ornate two and one-half story building with many bungalow features. The house is oblong, high gabled, and has an asphalt roof. Rafters extend beyond the eaves. Corner rafters extend about a foot beyond and curve into a bizarre point. It has stylish roof brackets and a one-bay porch. The roof of the porch is supported at both corners by two square posts each with cornice. The porch roof is high gabled. The area under the porch gable is filled in, giving an appearance of pediment. Door and windows have an entablature, and plain sides. Windows have lugsills and 1/1 panes. There is weatherboarding on porch and first two stories. The upper story has some kind of random shingle or weatherboarding. The weatherboards on the porch flare outward toward the bottom of the porch. Two one-window dormers with overhang are on the south side of the house. A two-window gable with overhang is on the front in a setback part of the house on the north side (which appears to be a separate apartment). The house has wooded water tables. Belt course consists of a board which comes to a low point in the center of the front of the house, giving a pedimental effect. Squared beam ends adorn the lower edge of the belt course.
